Re: Geotechnical Evaluation Report
20 Oak Road (APN 191-261-21)
Bolin, California

20 Oak Road Evaluation
Bolinas, California

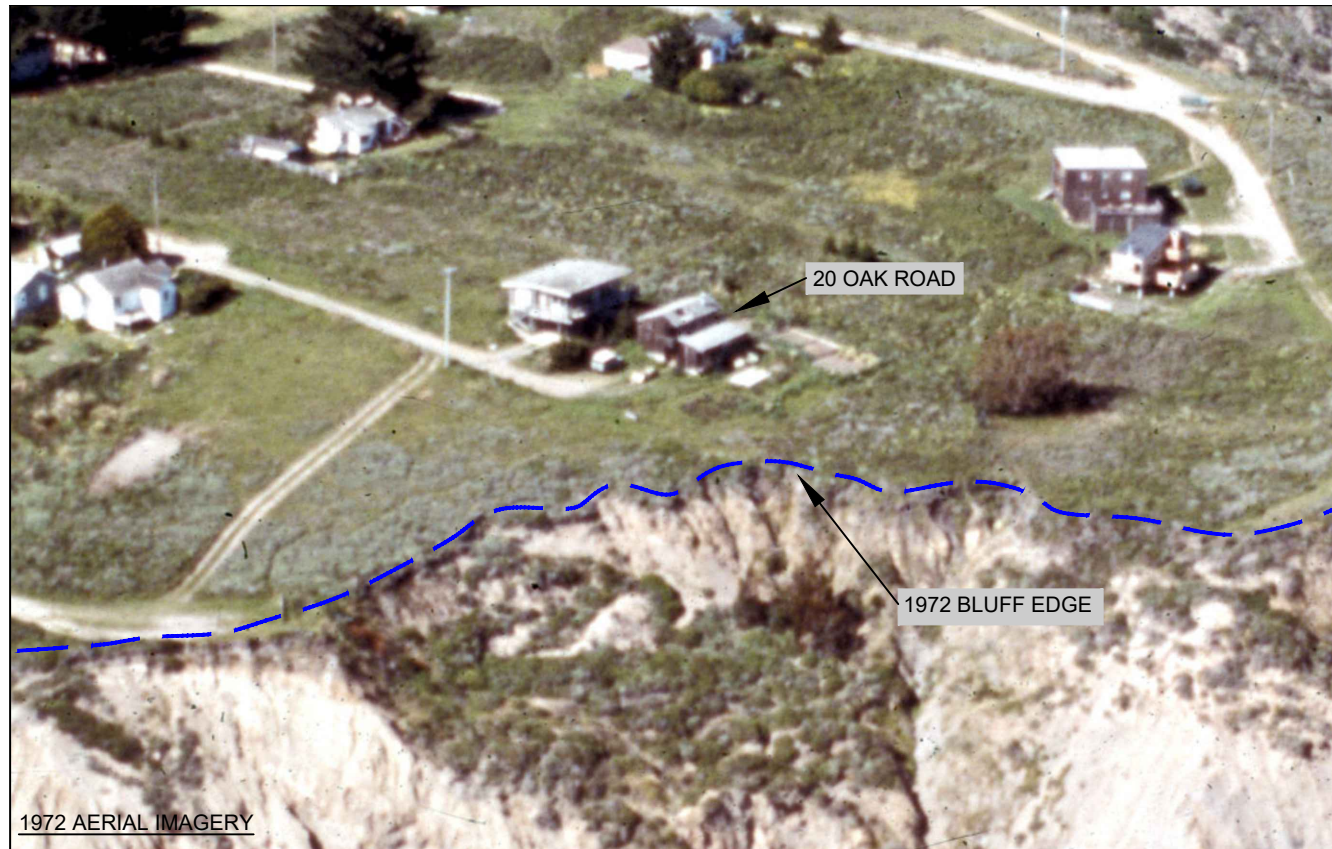
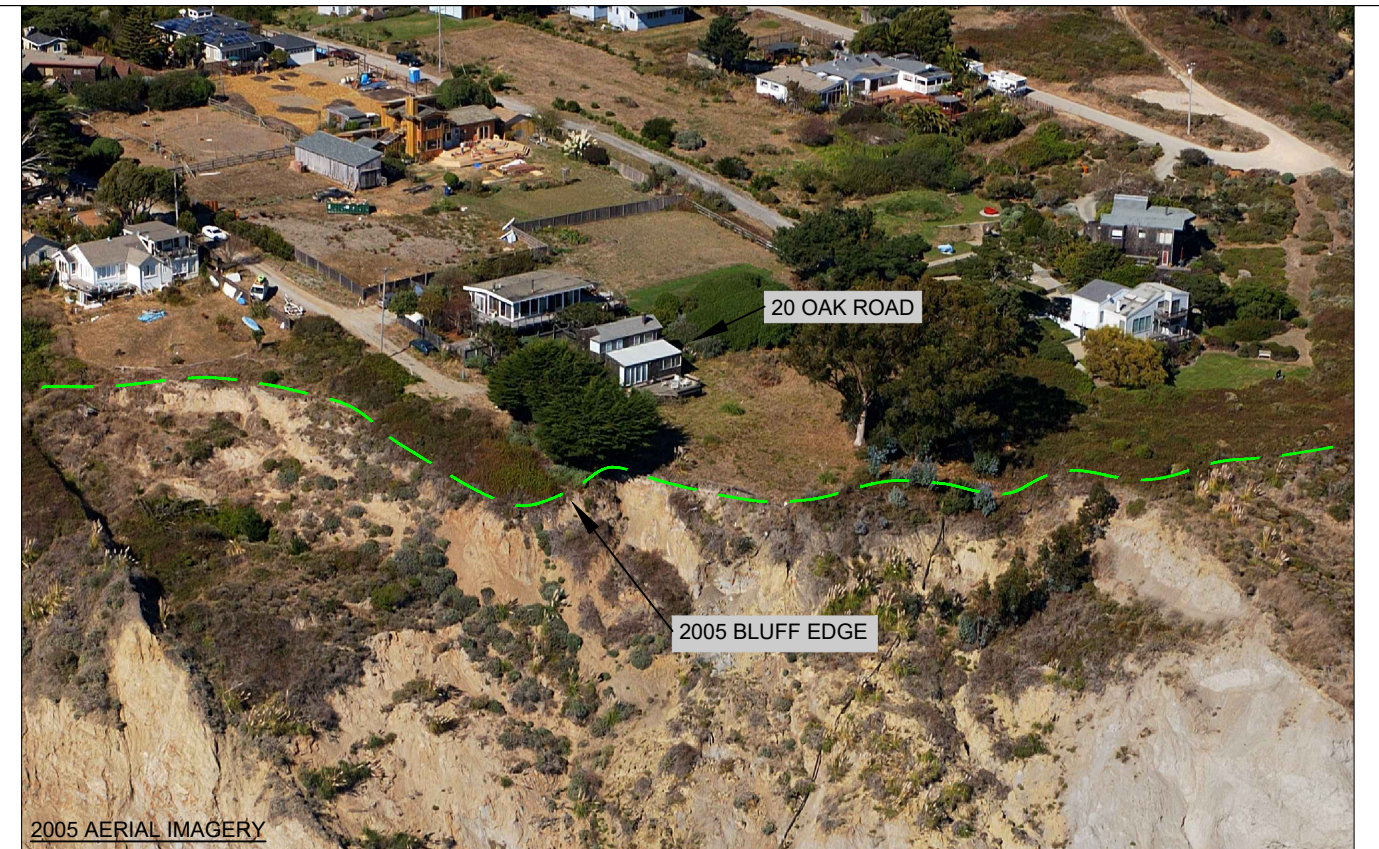
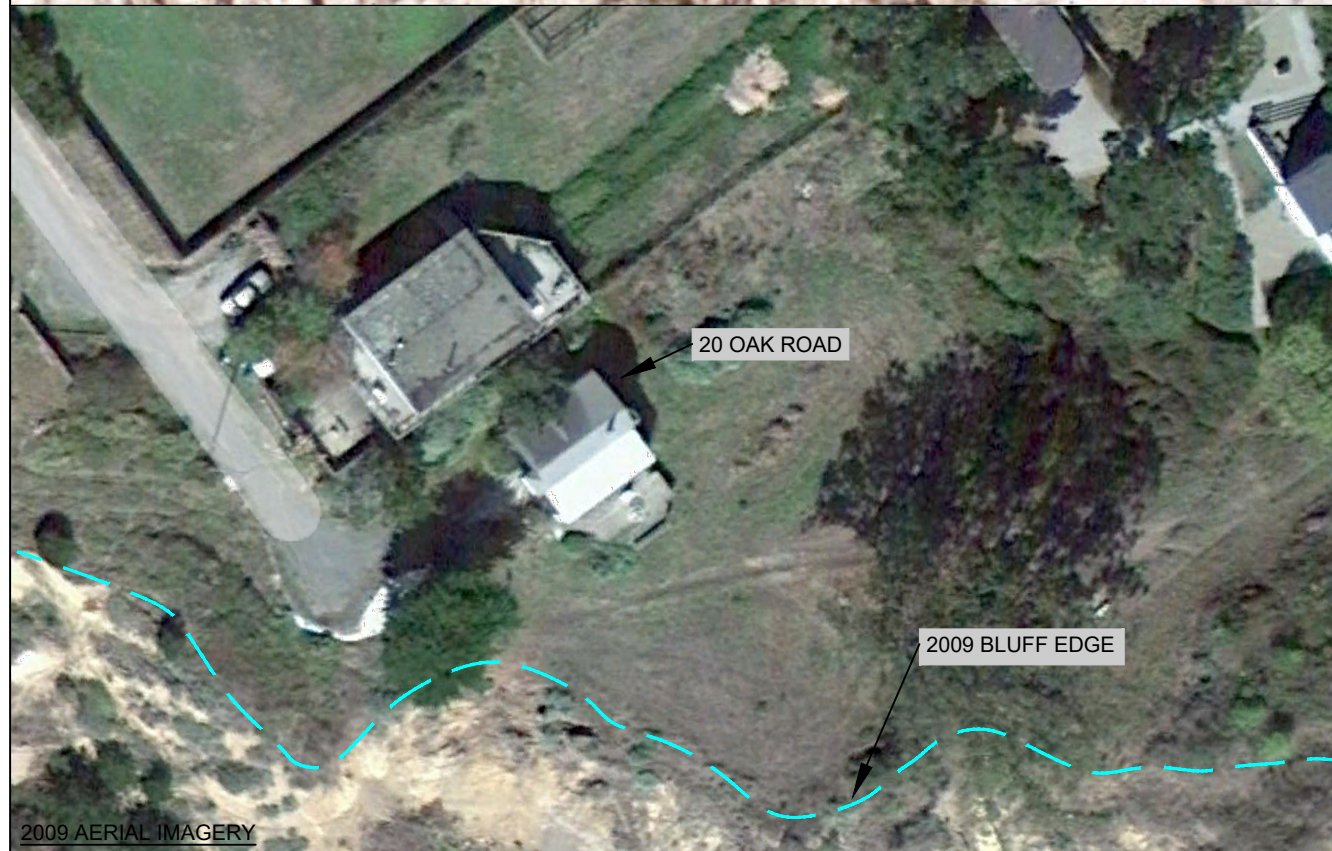
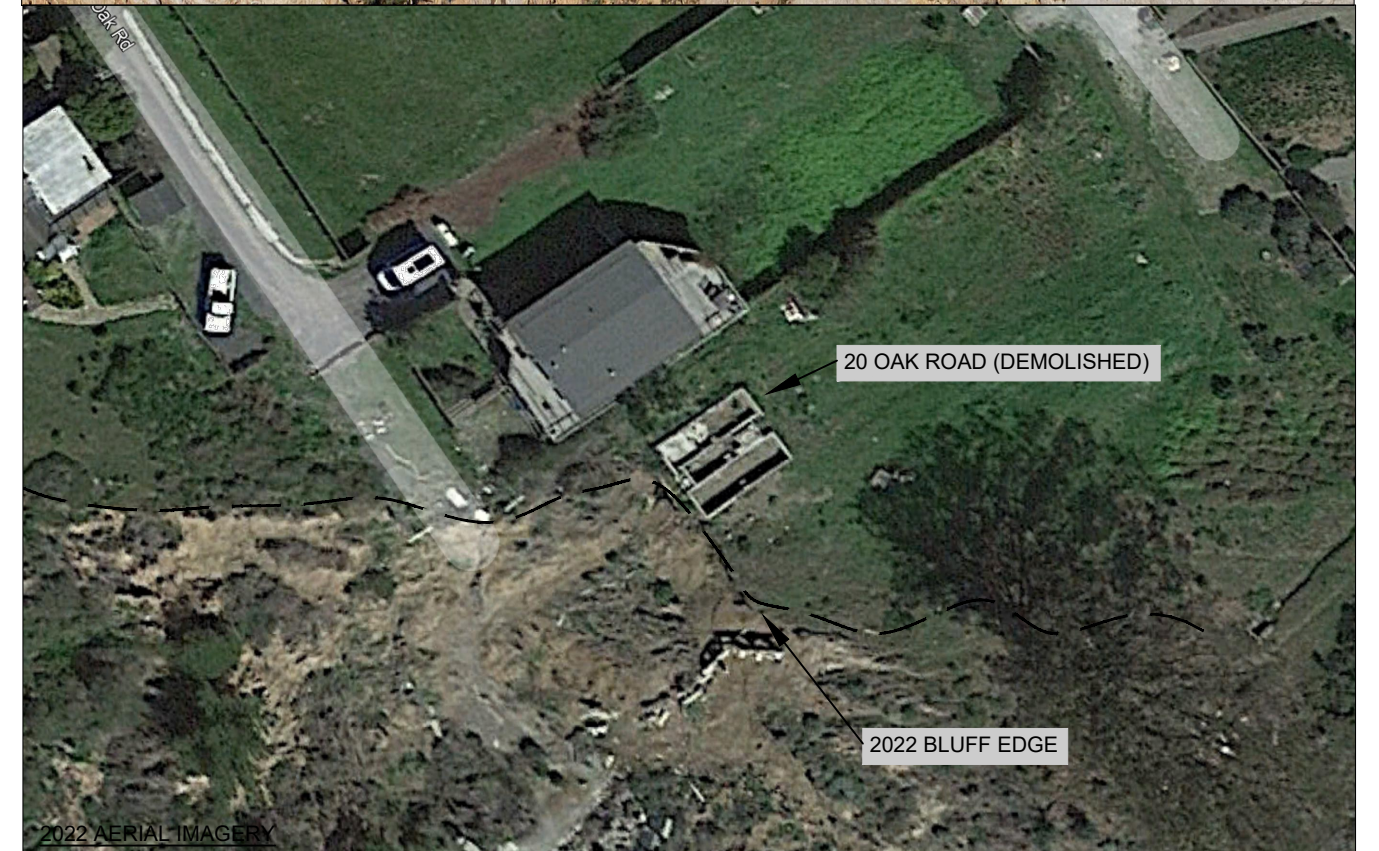
AERIAL IMAGERY 1972-2022

We also reviewed historic aerial photography from the California Coastal Records Project and Google Earth. Oblique-angle color photographs spanned the time period between 1972 and 2022. As shown on Figures 6, significant mass-wasting and bluff retreat has occurred, primarily within the southwest region of the site. More recent site-specific rates calculated from bluff edge positions between 2009 and 2022 generally agree with the historic average rate of 2.0-feet per year.

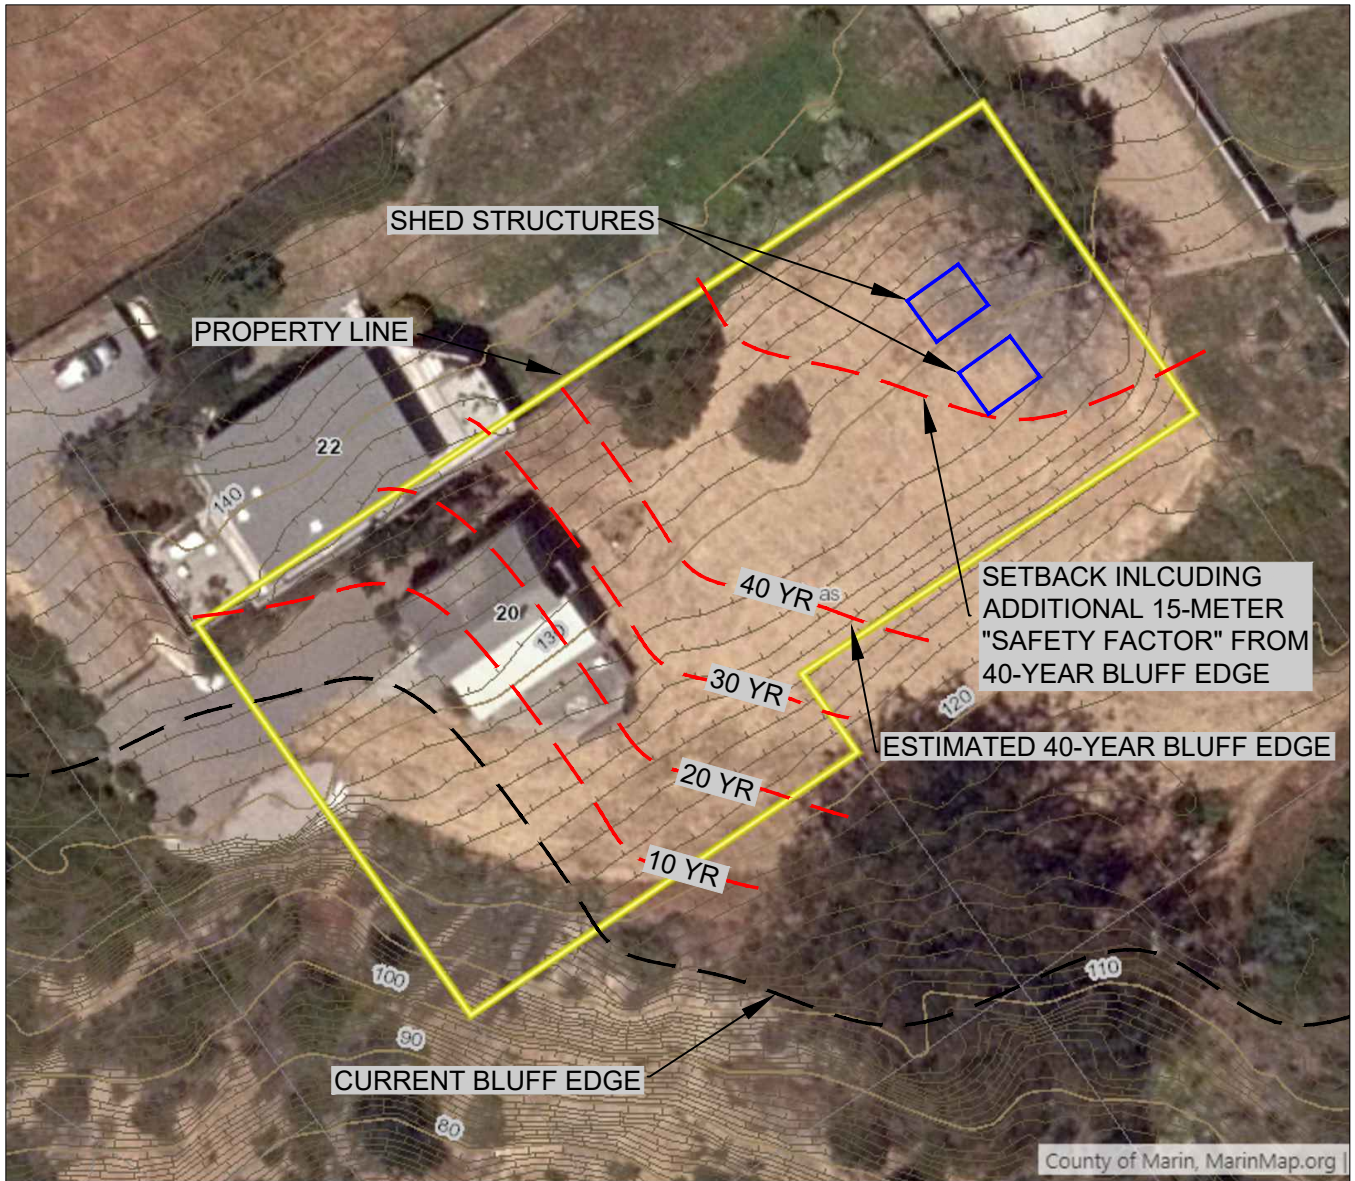
SITE-SPECIFIC BLUFF RETREAT

Per Marin County municipal code 22.56.130I.K.1, bluff top setback should be determined using the following formula: $\text{setback} = \text{structure life (at least 40 years)} \times \text{retreat rate (meters/year)} + 15$ meter safety factor where vigorous sliding is taking place. Based on an average annual retreat rate of 2.0-feet (0.6 meters) per year and a reasonable structure-life of 40 years, we estimate that a total of about 80-feet (24.4 meters) of bluff retreat should be anticipated.

We were unable to determine the definition of 'vigorous sliding'. We reviewed the Coastal Cliff and Bluff Erosion Technical Background Report⁴ published by Marin County in 2003, which states that, "Based on review of all the reported bluff erosion rates discussed above, the maximum rates reported thus far are . . . 32 inches per year for the bluffs between Duxbury Point and Poplar Road (including Duxbury Point)." Based on regional and site-specific bluff retreat rates, we judge the sliding to be vigorous for the region. Given the average annual retreat rate of 2.0-feet (0.6 meters) and an additional 15 meter safety factor, a 129.2-foot (39.4 meter) setback from the bluff edge should be provided. As shown in Figure 7, the southwestern half of the project site will likely be impacted by bluff retreat in the next 40 years. Slope instability/bluff retreat is considered a significant geologic hazard at the project site, especially in the southwest region of the property.

Evaluation: Less than significant with incorporated recommendations.
Recommendations: Recommendations include providing new structures with a 129.2-foot (39.4 meter) setback for a structure-life of 40 years to reduce the risk of damage or undermining by bluff retreat.

For a structure-life of 40 years, an average bluff retreat rate of 2.0-feet/year, and an additional safety factor of 15-meters, we recommend providing the sheds with a 129.2-foot setback from the bluff edge. If a longer structure-life is desired, the setback will need to be increased using the rate of 2.0-feet/year mentioned above.
