#### **A PRESENTATION**

# McNears Pier Damage

## MARCH 21, 2023: VESSEL IMPACT

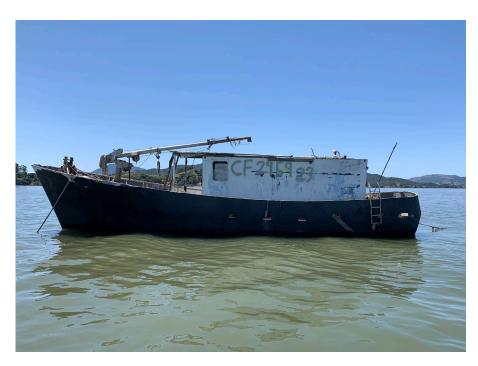
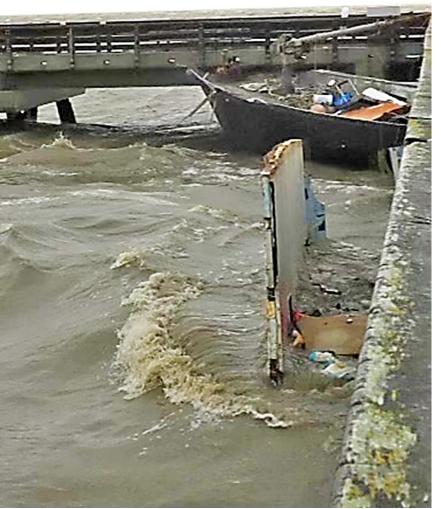
- 40' concrete vessel
- Mooring broke loose during storm
- Vessel struck pier on north side.

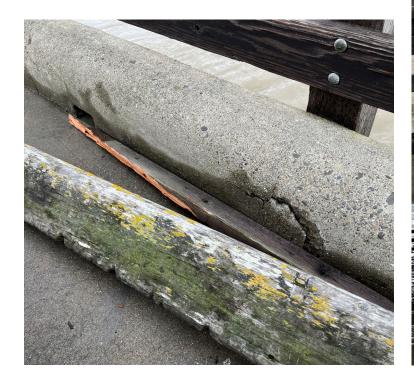
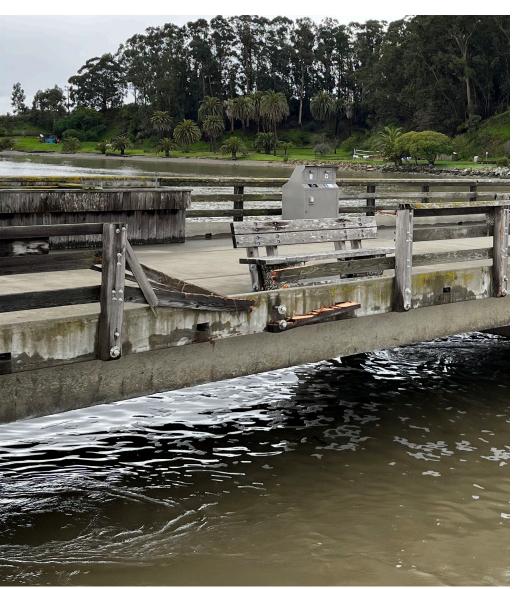
- Railing section damaged
- Concrete curb cracked
- Water line broken

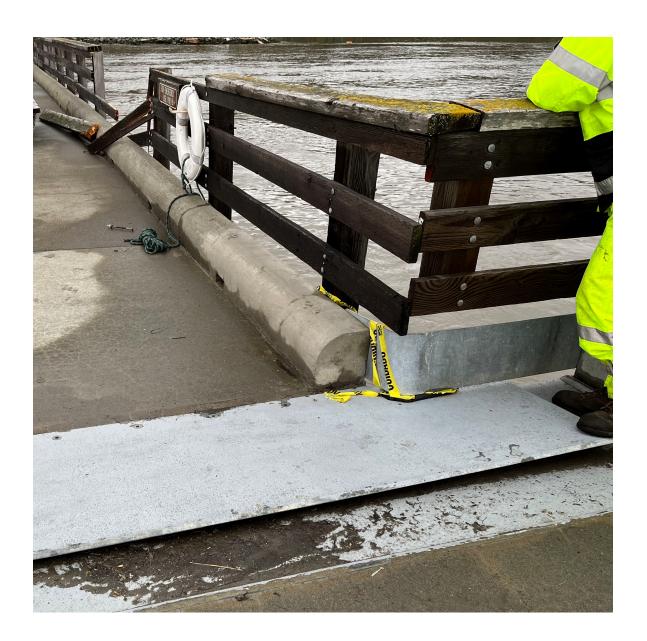
- Expansion joint at pier head lifted
- Pier shifted with impact
- For public safety, end of pier closed

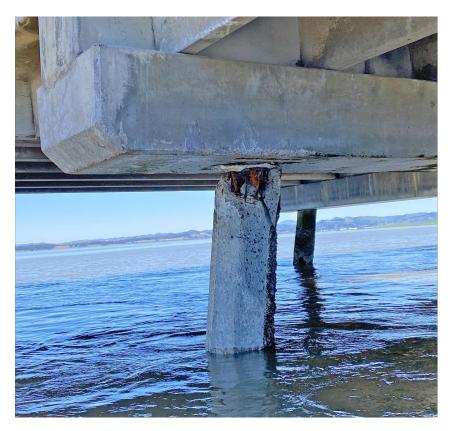
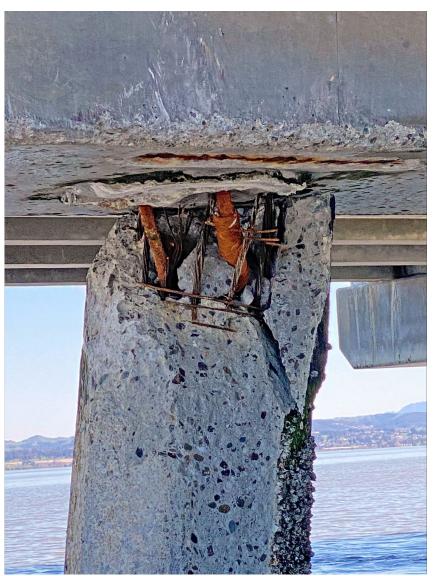
- Pile (F14) severely damaged
- Structural integrity compromised

- On March 25th BOS authorized contract for repair design
- With BOS authorization, begin emergency repair contracting procedures
- Support Risk Management with insurance claim efforts
- Repair pier and re-open pier upon successful project completion.

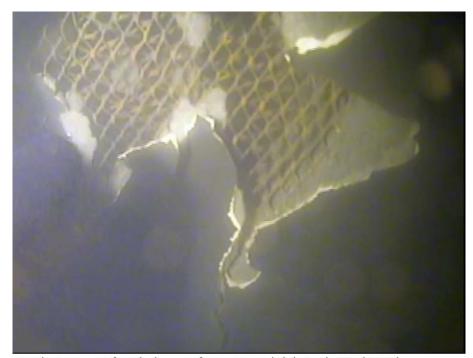
- Underwater assessment revealed more damage
- Vessel remnants leaning on pile

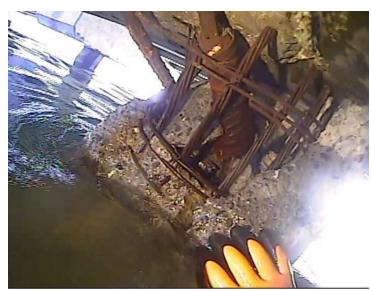
North Face – 10 feet below surface – Vessel debris abutted to pile

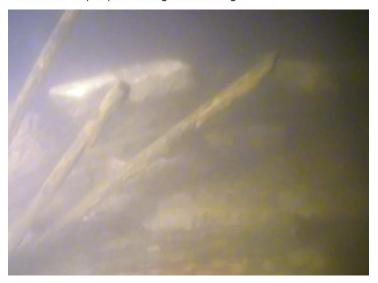
North Face – Top of pile showing severe damage

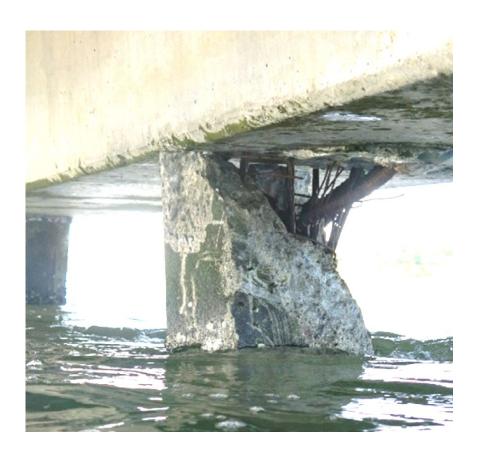
- Damage puts pier at risk of collapse if piling fails
- Potential causes:
  - Vertical and lateral movement
  - Minor seismic activity
  - Deterioration from localized waves/currents
  - Another collision (even if indirect)
  - Storm wind and waves
- Failure risk increases with each day
