**SITE VISIT REPORT  
MCNEARS BEACH FISHING PIER  
INITIAL ABOVE DECK DAMAGE REVIEW  
FOR COUNTY OF MARIN  
VISIT DATE: MARCH 23, 2023**

Prepared by Liftech Consultants Inc.  
Preparation Date: March 26, 2023

Project No. 2421

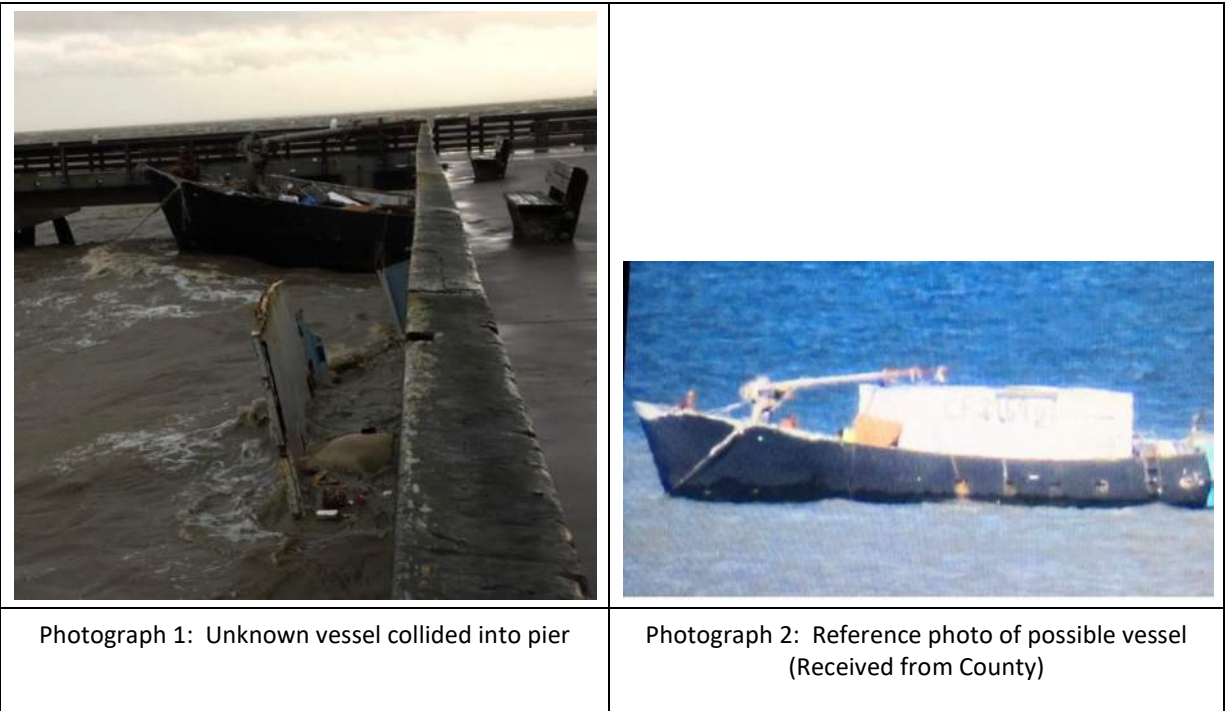
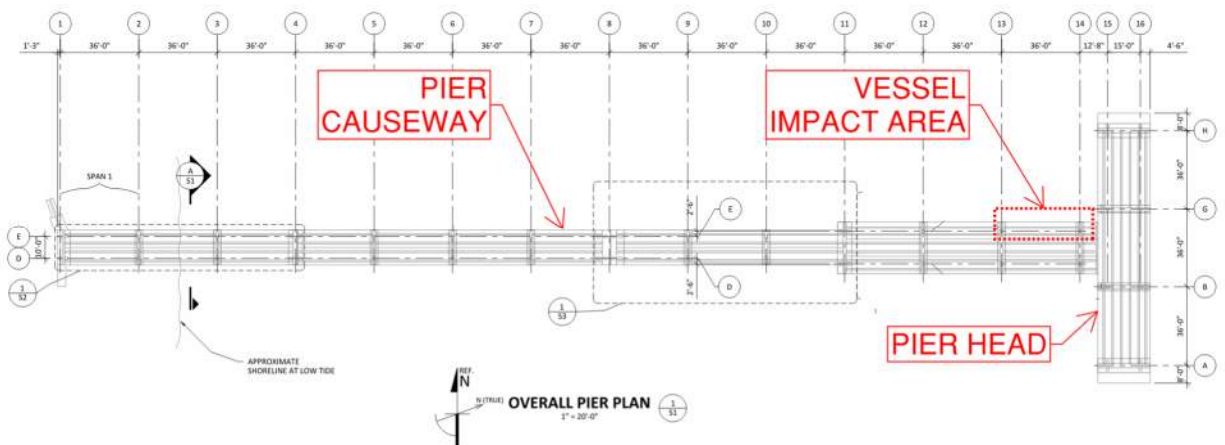
Figure 1: Overall pier plan with terms and impact area

On Tuesday, March 21, 2023, a severe storm with high winds occurred in the Bay Area. An unknown vessel was blown from the north into the McNears Beach Fishing Pier. The vessel collided into the north side of the pier causeway near the intersection with the pier head. See photographs and Figure 1 below.

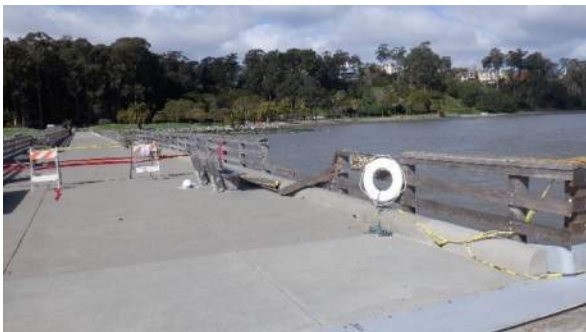
<p>Photograph 3: Barricaded area</p>	<p>Photograph 4: Broken wood railing</p>

1. Move the public access barricade of the damaged area one bay back to Bent 12.
2. Install temporary railings to replace the broken railings.
3. Install temporary shoring to support the causeway deck near Bent 14.
4. County to obtain emergency permits for temporary shoring installation.

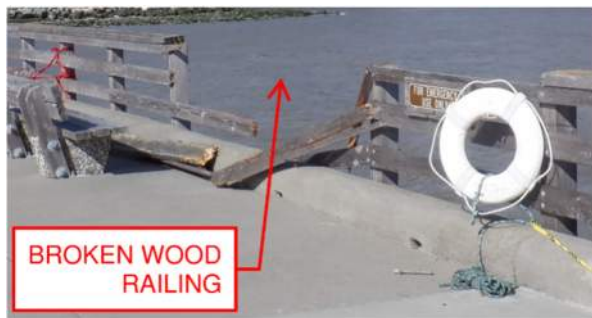
The above-deck damage appears localized at the vessel collision area. The broken wood railing presents a safety hazard to the public. Concrete cracking on the bull rail does not affect the structural integrity of the pier structure, and only affects the railing anchorage and railing support strength. The pier causeway is straight and appears reasonably aligned (centered) with the pier head.

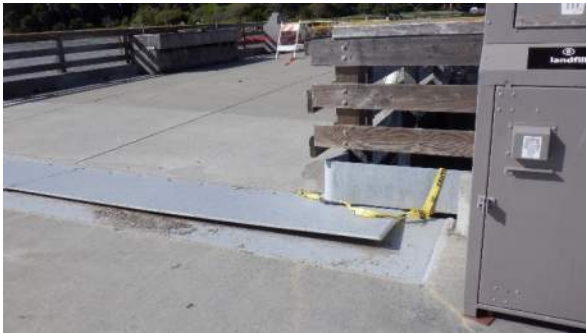
<p>Photograph 5: Plate bent up by 3”</p>	<p>Photograph 6: Apparent offset at north end of causeway</p>

Although not confirmed with measurements, the north end of the causeway appears to be lower than the adjacent pier head. This movement is likely the cause of the bent expansion joint cover plate. It is also possible that the cover plate and associated vertical closure plate were bent during a temporary movement of the pier.

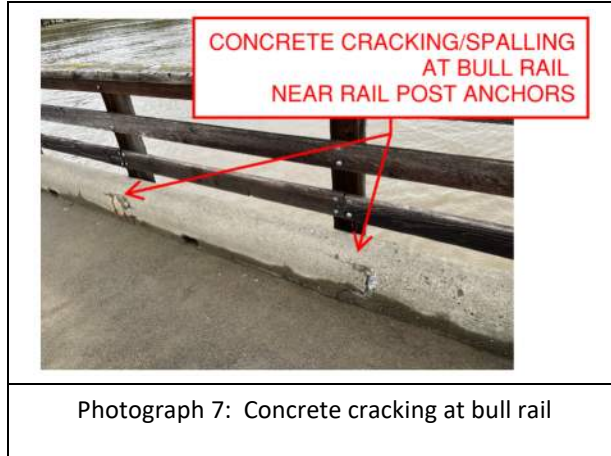
1. The pier section where the vessel collided was barricaded at approximately Bent 13 (see photograph 3).
2. A section of the wood railing was broken (see photograph 4).
3. The north side of the expansion joint steel cover plate between the pier causeway and head was bent upward about 3” (see photograph 5).
4. The north end of the pier causeway may be approximately 2–3” lower than the pier head (see photograph 6). This comment is based only on our visual observations. Levelness and elevations were not measured.
5. Minor concrete cracking at the bull rails (see photograph 7) where the railing posts are anchored.

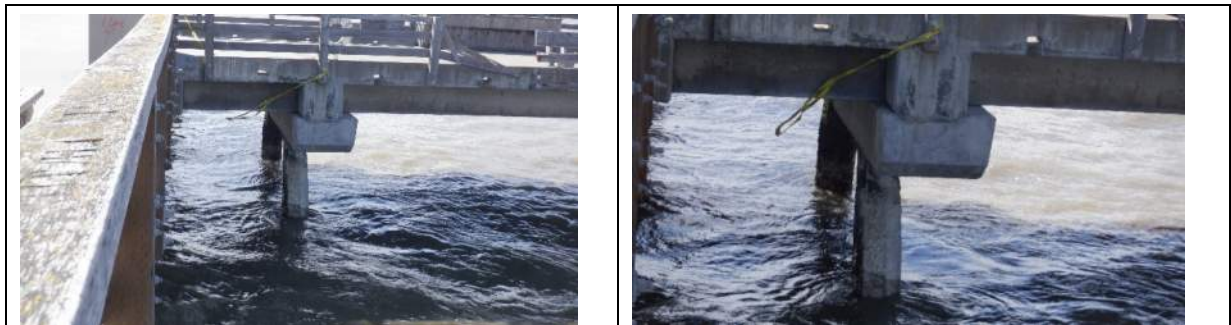
We expect the piles at Bent 14 are deformed and may be damaged. Photographs 8 and 9 show that pile-beam connections appear to have some damage.

Photographs 8 and 9: Possible damage at pile-beam connections at Bent 14

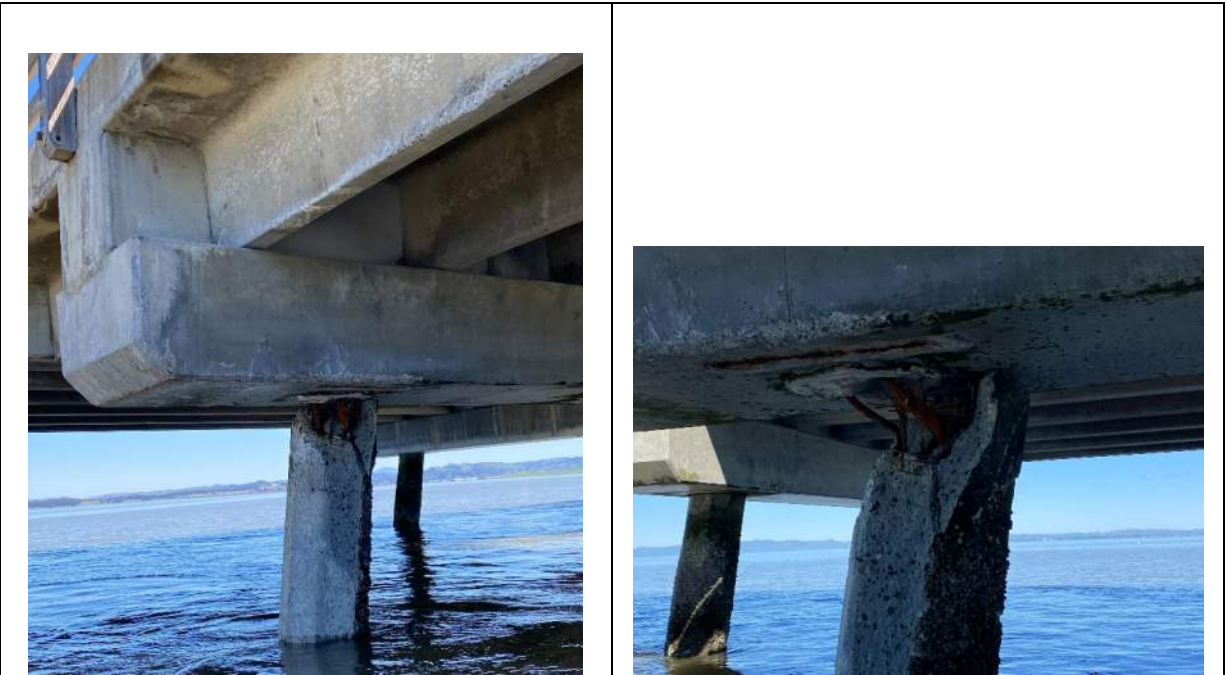
On 03/26, Marin County provided photographs 10 and 11 that show significant damage at the pile-beam connection at Pile F14. These photographs show that the top of the pile has been translated from its original position. The pile cap rests on a small portion of the pile top. It is likely that approximately 2-3" of the top of the pile fell off which allowed the north end of the pile cap to lower.

Translation restraint of the pile top is compromised. If subjected to lateral loads, it is possible that the pile cap could lose support if it slid off the pile top. If pile support is lost, the end of the causeway could collapse. Liftech has not performed calculations to evaluate this condition, but the causeway structure does not have significant torsional strength to support the asymmetric support condition. This condition should be mitigated immediately with temporary shoring to reduce the possibility of partial causeway deck collapse. With temporary shoring in place, further investigation of the piles, design, bidding, and construction of the repairs can be completed safely.

Photographs 10 and 11: Damaged north pile-beam connection at Pile F14

5. Perform a below-deck visual review of the structural condition of the double tee beams, pile cap beams, and pile-beam connections from Bents 12 through 16 as soon as practical.
6. Perform an underwater inspection of piles at Bents 13-14 and intersection of Bents G-15. At a minimum, Piles F13, F14, and G15 shall be inspected. If possible during pile inspection, we recommend determining if there is a sunken vessel at this location.
7. Design and implement repairs to restore the pier structure.
