**SITE VISIT REPORT
MCNEARS BEACH FISHING PIER
UNDERDECK AND UNDERWATER DAMAGE REVIEW
FOR COUNTY OF MARIN
VISIT DATE: APRIL 14, 2023**

Prepared by Liftech Consultants Inc.
Preparation Date: April 20, 2023

Project No. 2421

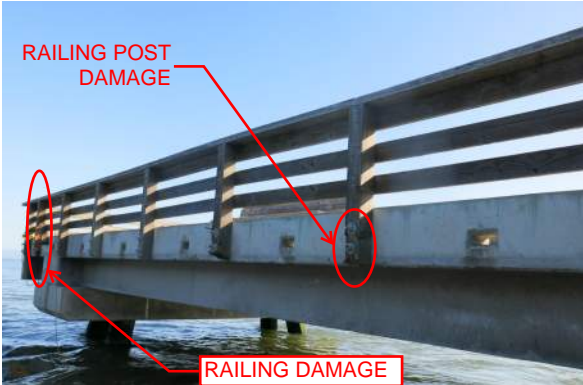
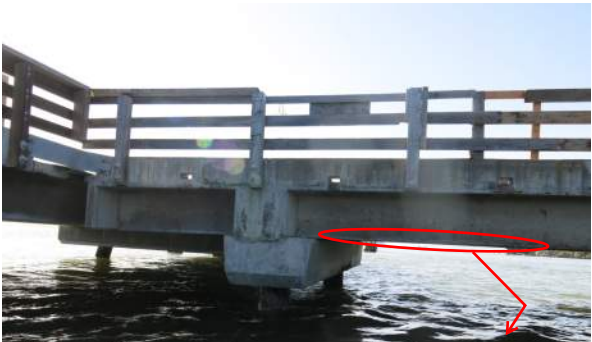
1. Although not confirmed with measurements, the north end of the causeway appears to be approximately 3" lower than the adjacent pier head.
2. The pier head structure does not appear to be damaged, other than localized damage to the railing and expansion joint. See Photograph 1 for damaged railing posts.

<p>RAILING POST DAMAGE</p> <p>RAILING DAMAGE</p>

<p>Photograph 1: Railing damage on pier head</p>	<p>Photograph 2: West end of causeway (north side)</p>

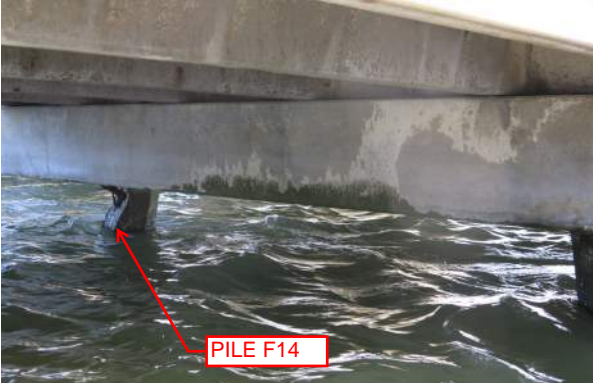
3. Pile F14 – The top of Pile F14 is severely damaged. See Photographs 7–11.
4. Span 13-14 – The bottom of the outboard tee on the north face of Span 13-14 has minor abrasion that does not impact the strength of the structure, but reduced cover may result in accelerated corrosion.

<p>PILE F14</p>	  <p>MINOR ABRASION AT BOTTOM OF OUTER TEE ON NORTH SIDE OF SPAN 13-14</p>
<p>Photograph 3: Pile Cap 14 west face</p>	<p>Photograph 4: Abrasion at tee bottom at Span 13-14</p>

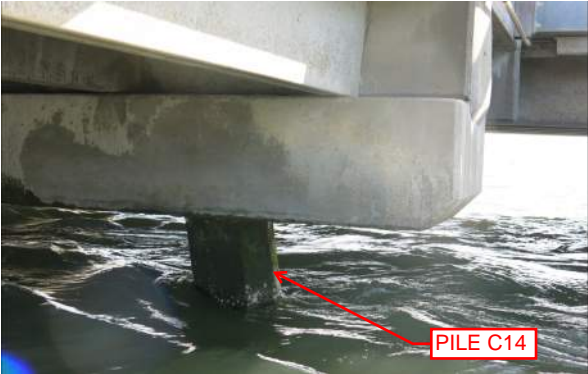
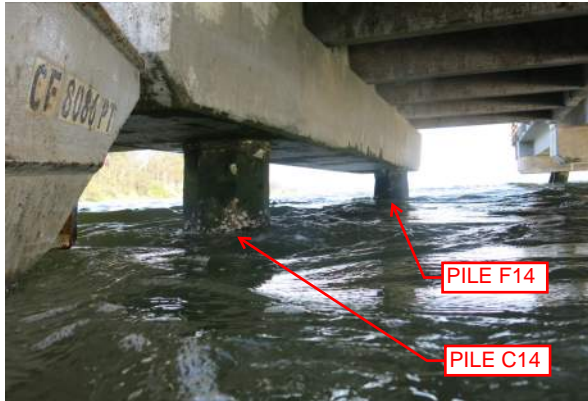
12. Pile C14 – Diver reported cracking around the perimeter of the top of Pile C14. Due to access restrictions, details about this crack could not be obtained. It is possible that this damage was caused by lateral movement of the causeway during impact.

<p>PILE C14</p>

<p>PILE F14</p> <p>PILE C14</p>
<p>Photograph 5: Pile Cap 14 west face</p>	<p>Photograph 6: Pile Cap 14 east face</p>

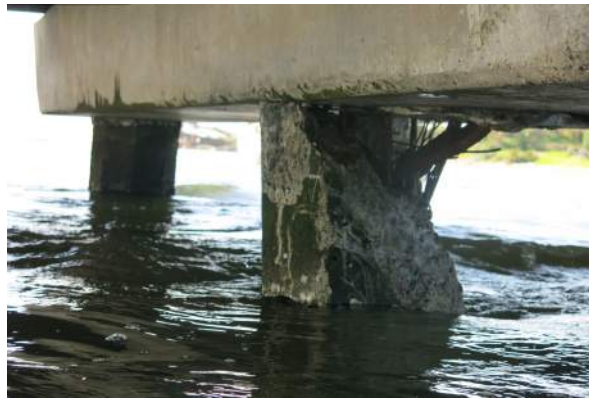
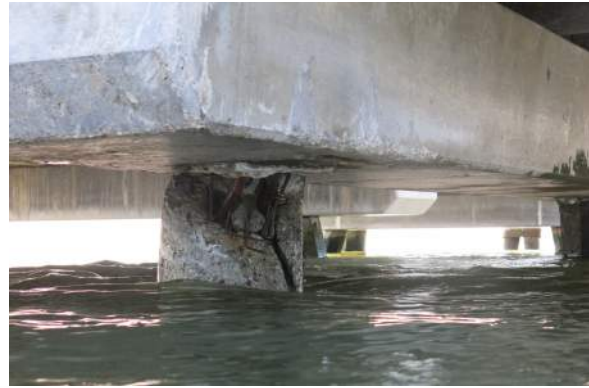
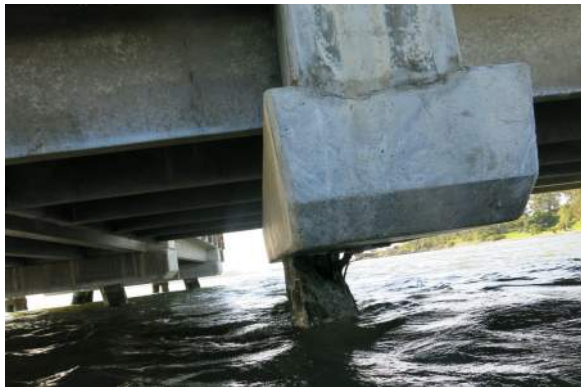
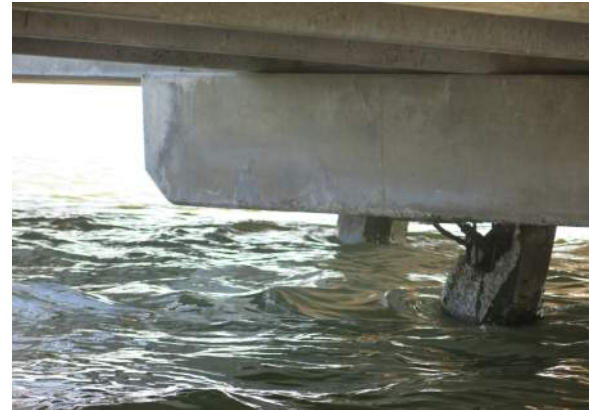
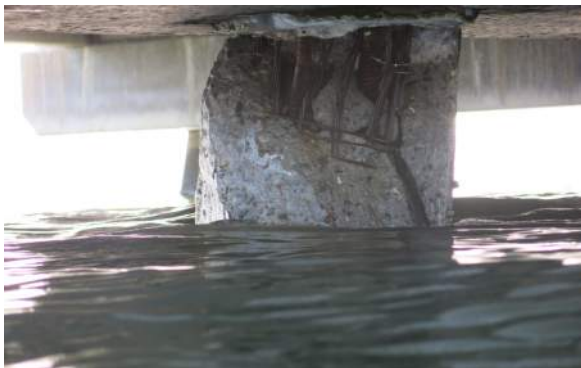
11. Pile F14
 - a. Severe damage at the pile-cap connection.
 - b. Diver reported chipping on the north and west faces of the pile down to approximately 4'±6" below the bottom of the pile cap.

- c. Remnants of the vessel (e.g., 1/4" round steel bar and fiberglass w/steel mesh) remain at the west and north faces of the pile. Some components wrap around the pile. Diver was not able to inspect pile at this area due to unsafe conditions.

Photograph 7: Pile F14

1. Install temporary shoring to support the northwest end of the causeway deck near Bent 14.
2. Remove remnants of vessel around Pile F14 and confirm that no further pile damage was observed.

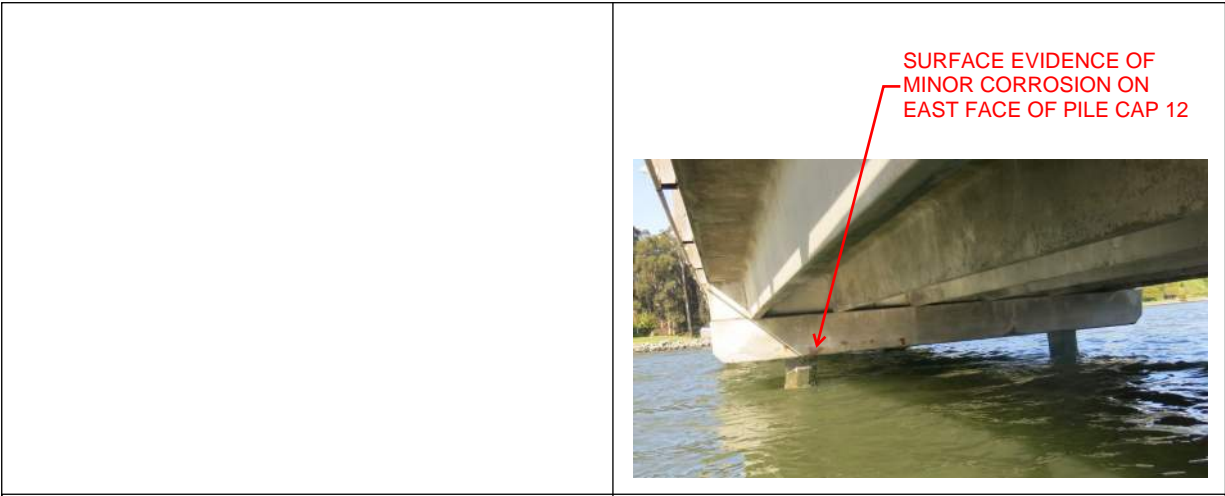
7. Pile Cap Beam 13 – The west and east faces of Pile Cap 13 have cracks.
8. Pile Cap Beam 12 – The east face of Pile Cap 12 shows some minor evidence of corrosion.

Observations 7 and 8 do not affect the strength of the pier and are not likely to have been caused by the vessel impact.

Photograph 12: Pile Cap 12 east face

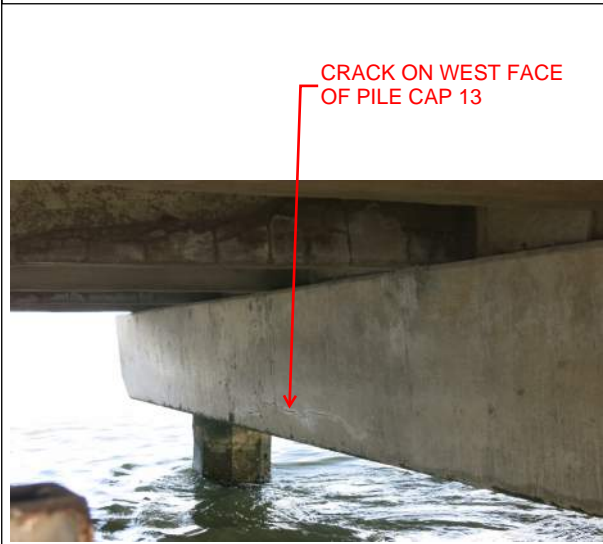
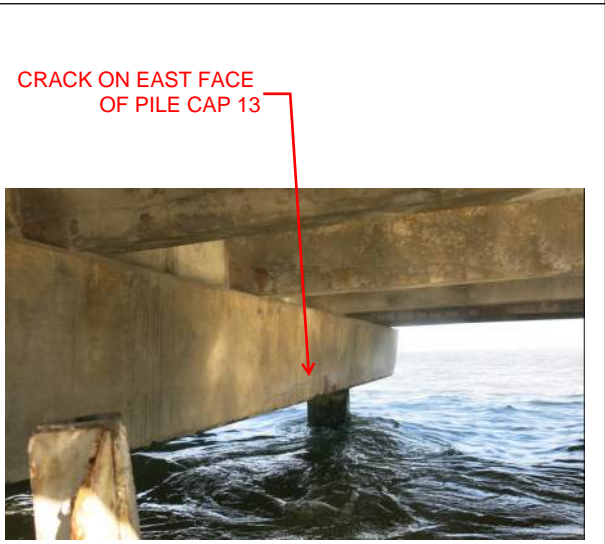
Photograph 13: Pile Cap 13 west face

Photograph 14: Pile Cap 13 east face

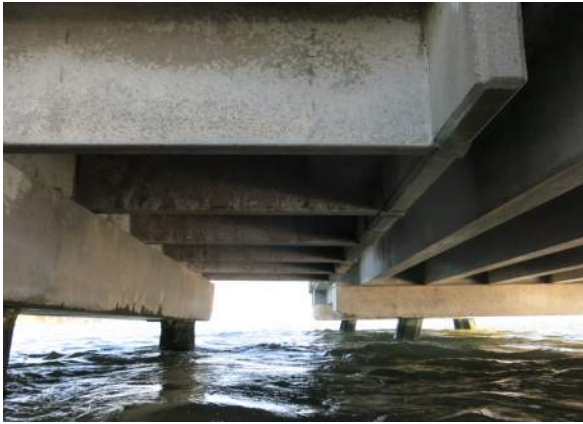
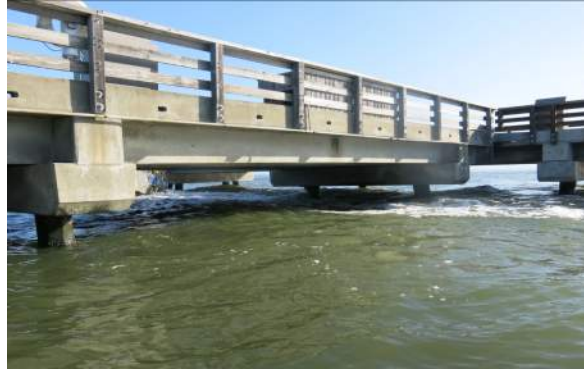
5. Pile Cap Beam 14 – No damage observed.
6. No damage observed at double tees at cantilever end and north face of causeway when viewed from outside of pier. See Photographs 15–16.

Photograph 15: East end of causeway (at exp. jt.)

Photograph 16: Span 13-14 south face

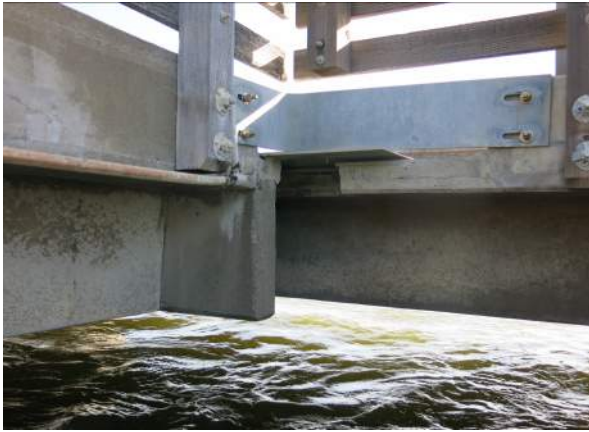
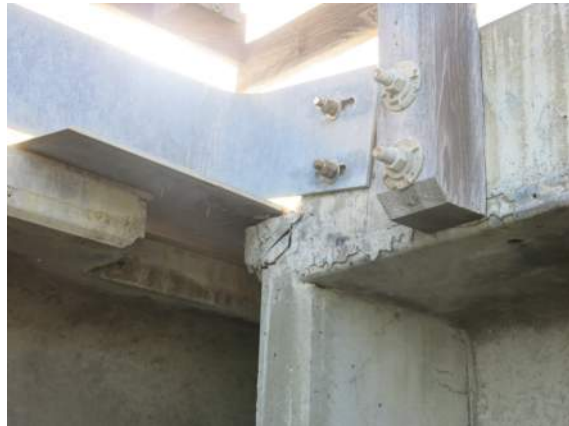
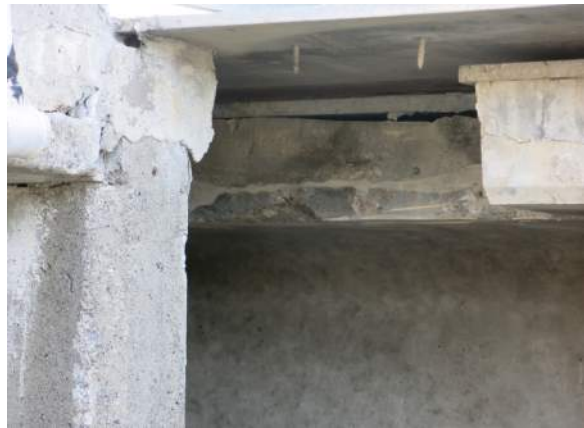
9. Toe plates at the expansion joint are displaced and possibly deformed. See Photographs 17–18.
10. Public access on the pier causeway was blocked off at Bent 11.

Photograph 17: Expansion joint - north side

Photograph 18: Expansion joint - south side

Photograph 19: Expansion joint - south side - detail

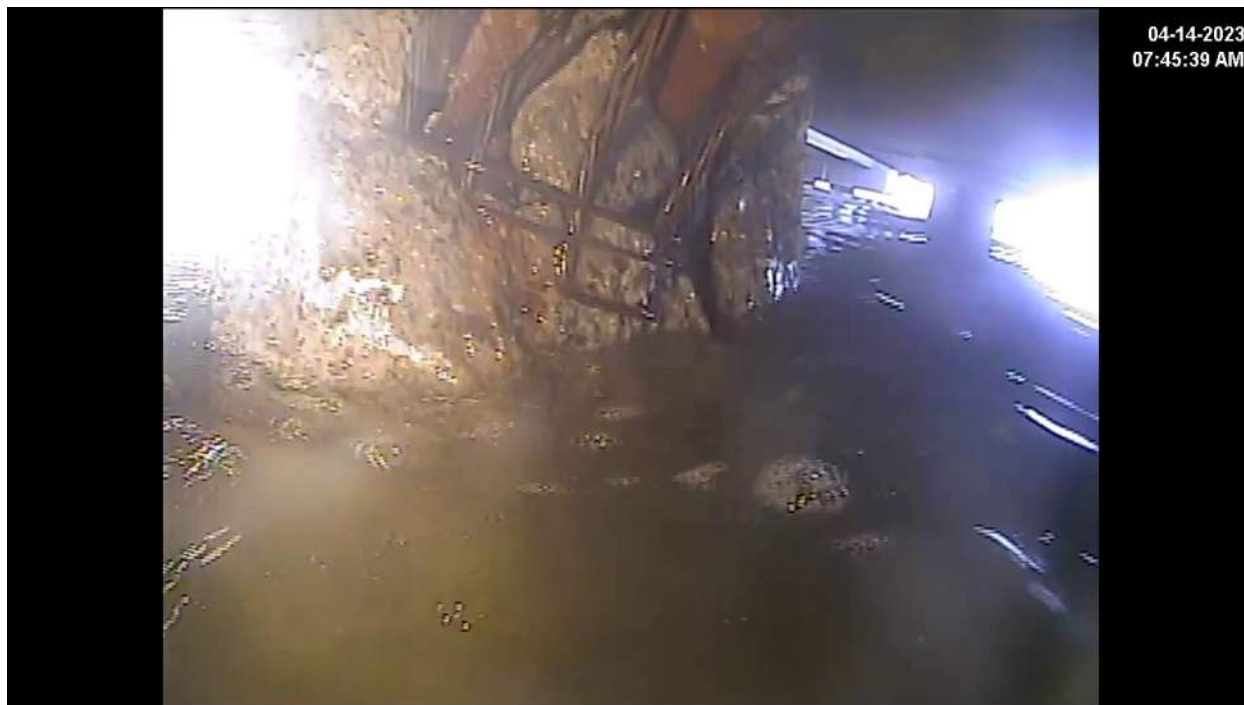
Photo 1 – F14 – North Face – Top of pile showing severe damage

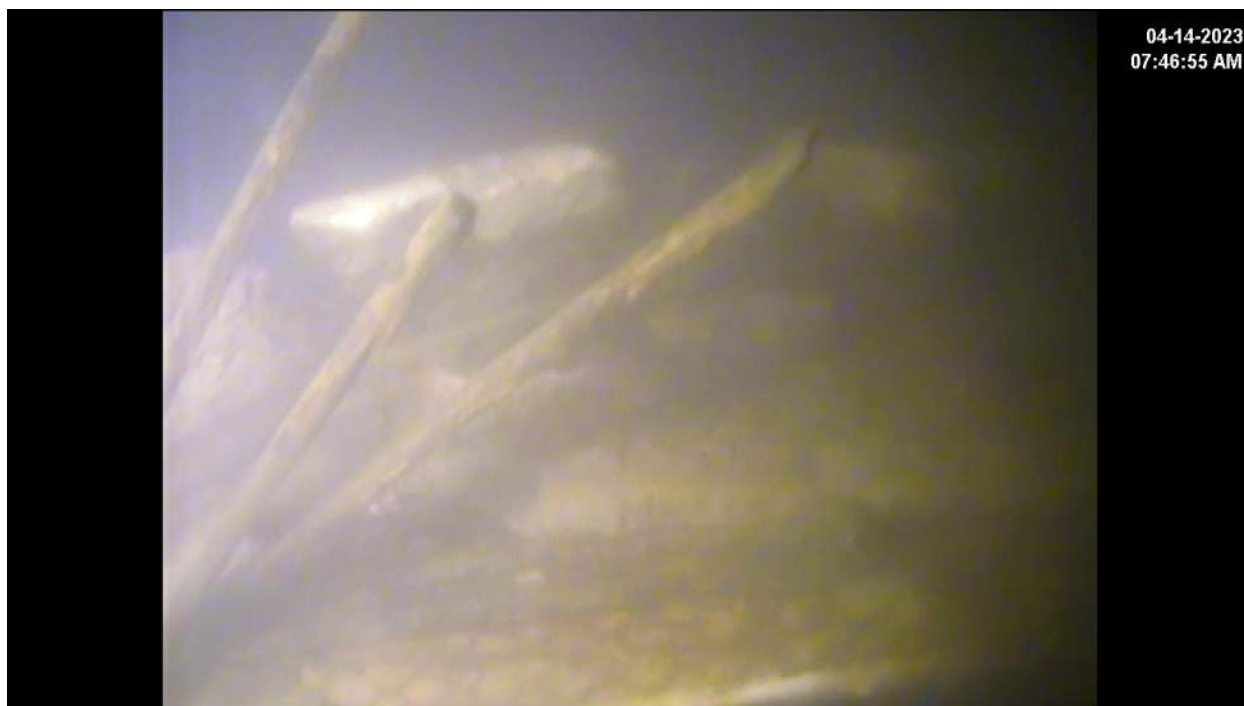
Photo 2 – F14 – North Face – 10 feet below surface – Vessel debris abutted to pile

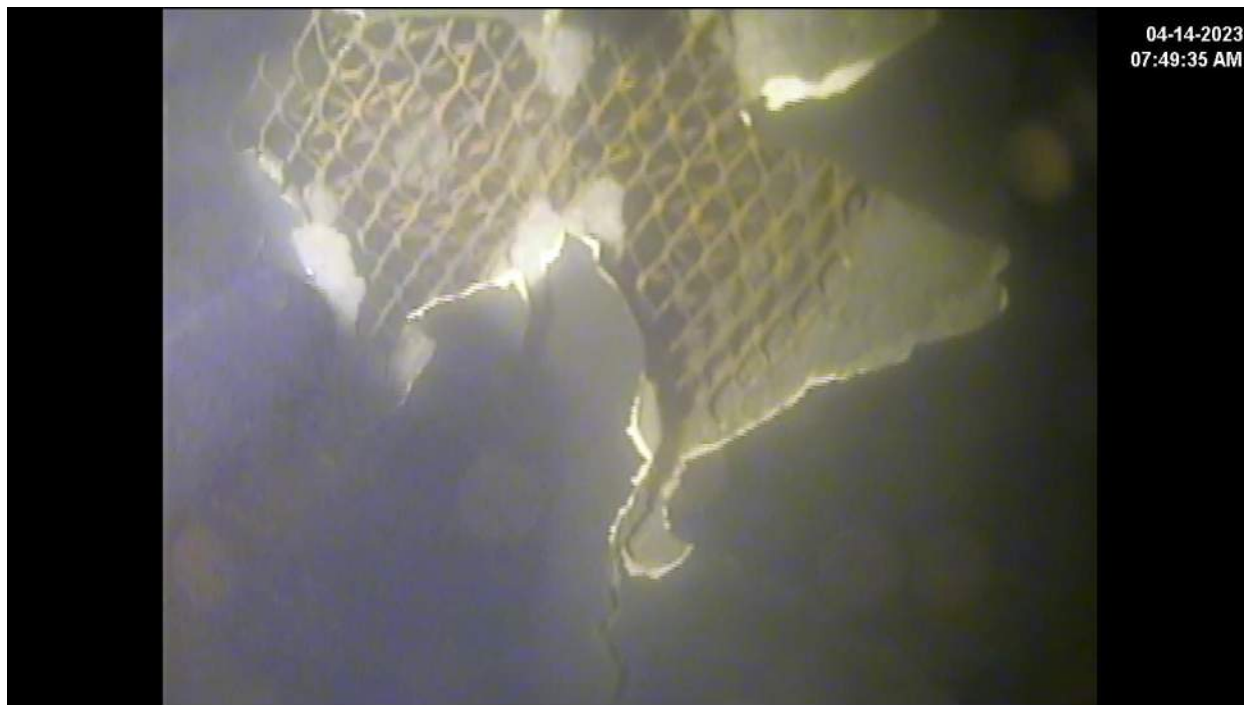
Photo 3 – F14 – North Face – 10 feet below surface – Vessel debris abutted to pile

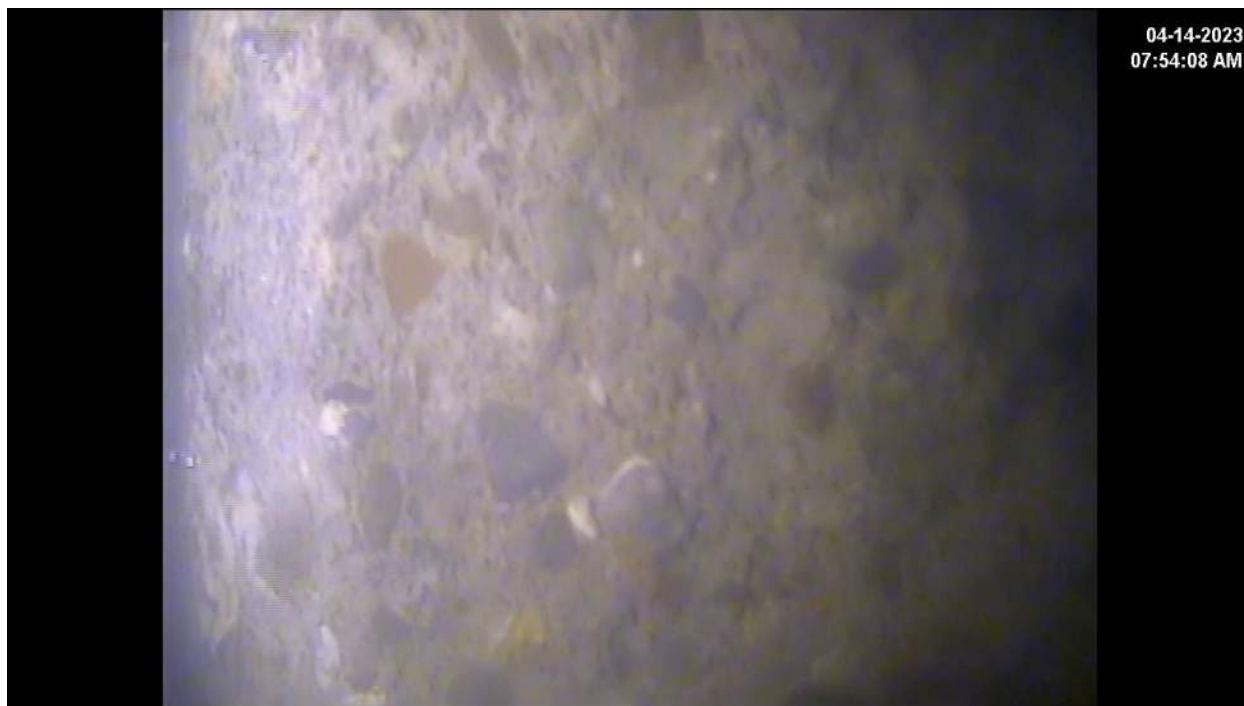
07:54:05 A 2-foot square section of 1-inch depth on the west face of F14 is sheared off 4 feet below the surface. Exposed aggregate is showing as a result.

Photo 4 – F14 – West Face – 2ft square section is sheared off 4 feet below the surface.

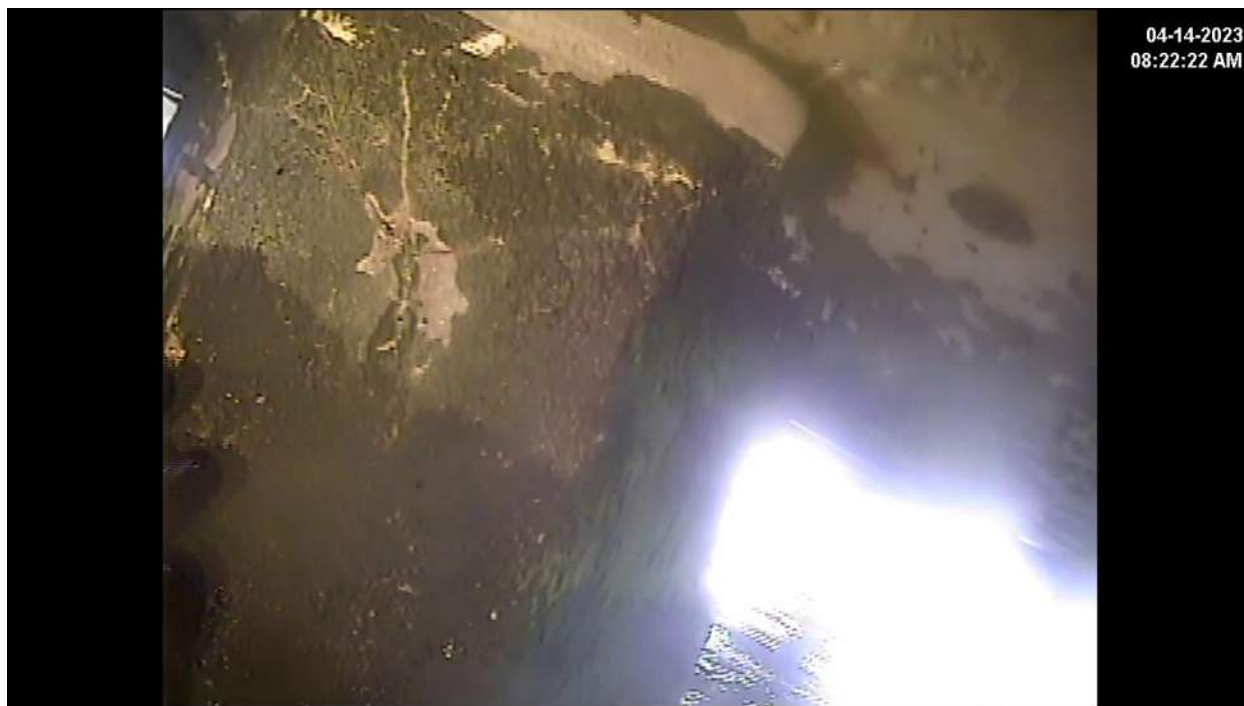
08:22:17 Diver at surface on C14. Diver notes moderate cracking around the top of the pile.
08:22:55 Diver descending west face of C14. No damage to pile. Vessel debris on bottom.

Photo 6 – C14 – Diver notes moderate cracking around the top of the pile.

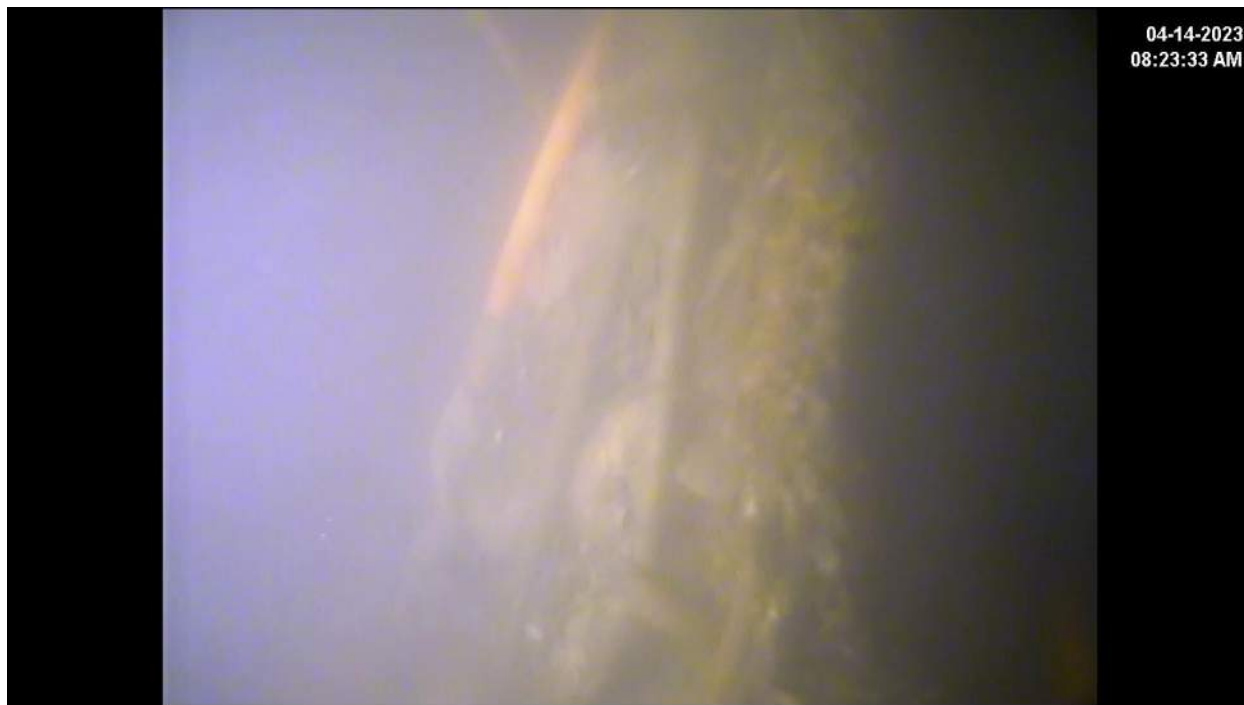
Photo 7 – C14 – West Face – Vessel debris on bottom

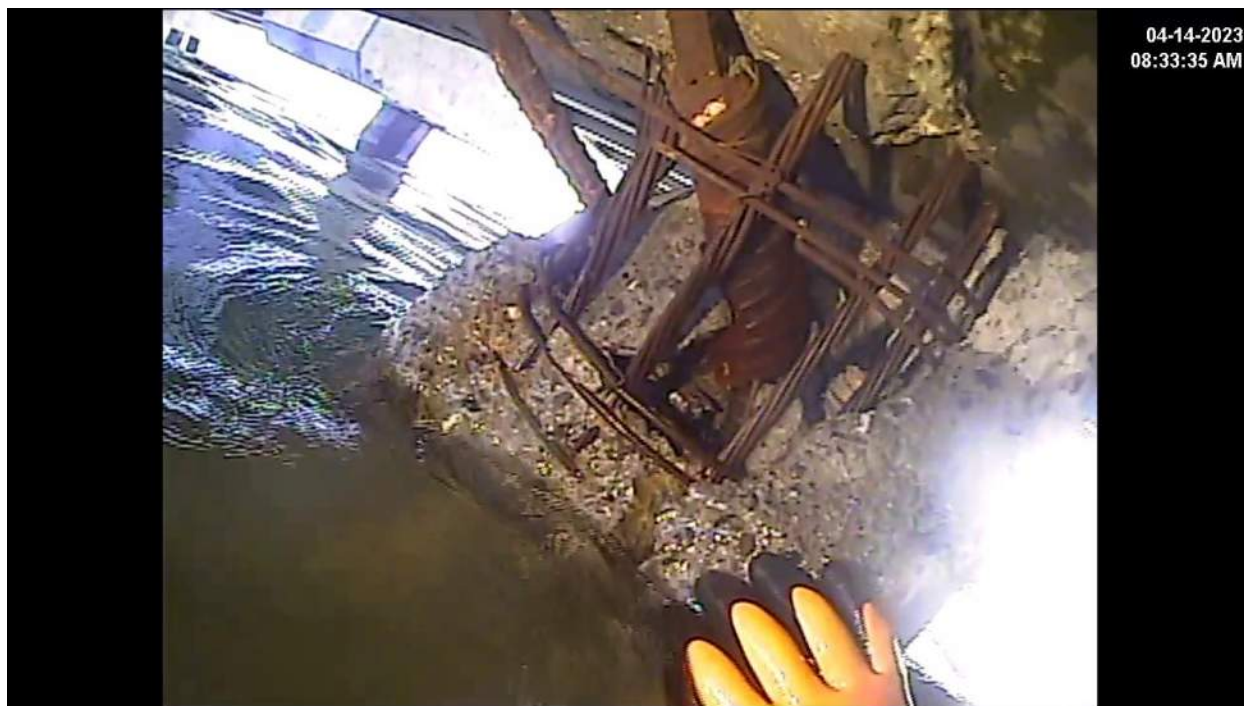
08:32:30 Diver at vessel debris on F14. Topside confirms top of debris at 13 feet of water depth.
08:34:35 Diver measures damage at top of F14 to be 4 feet in height.

Photo 8 – F14 – North Face – Top of pile showing severe damage
