**STAFF REPORT TO THE MARIN COUNTY  
DEPUTY ZONING ADMINISTRATOR  
Yerington Coastal Development Permit & Design Review**

**Recommendation:** Approve with conditions  
**Hearing Date:** June 6, 2024

The applicant requests Coastal Development Permit and Design Review approval to construct two, detached accessory structures (sheds) on a vacant lot in Bolinas. The 240 square feet of proposed development would result in a floor area ratio of one percent on the 18,000 square foot lot. The proposed accessory structures would reach a maximum height of 14 feet, 8 5/8 inches above surrounding grade and the exterior walls would have the following setbacks on the through lot: over 150 feet from the southwestern front property line; 25 feet, 9 1/2 inches from the northwestern side property line; 25 feet, 8 1/2 inches from the southeastern side property line; and 25 feet, 5 inches from the northeastern front property line.

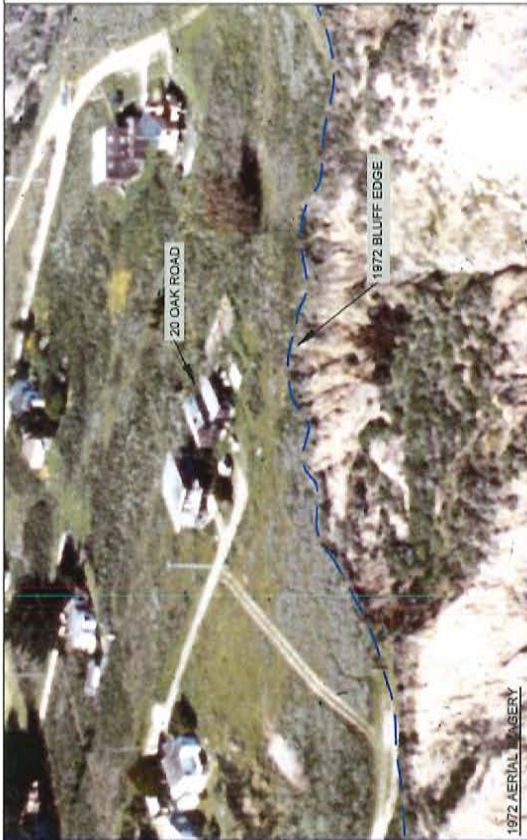
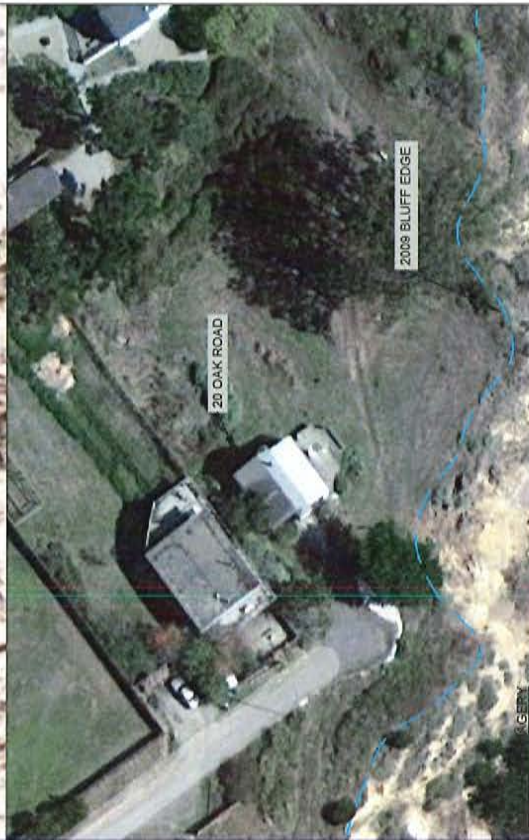
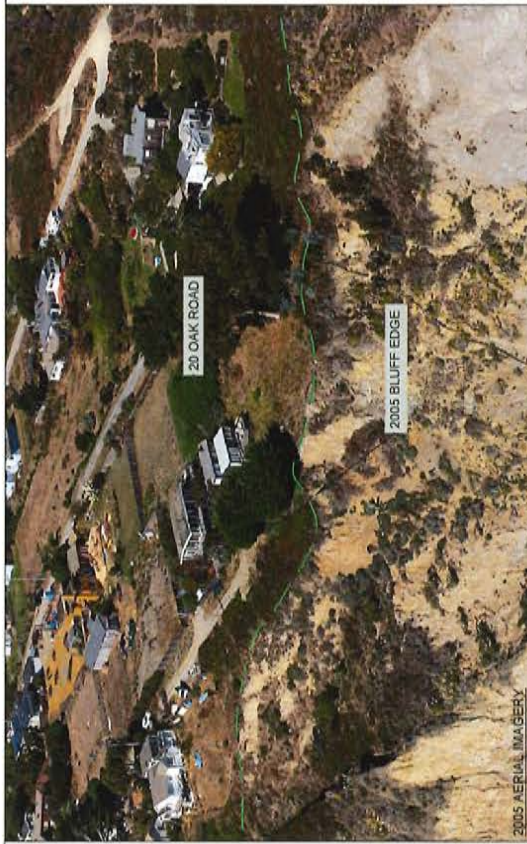
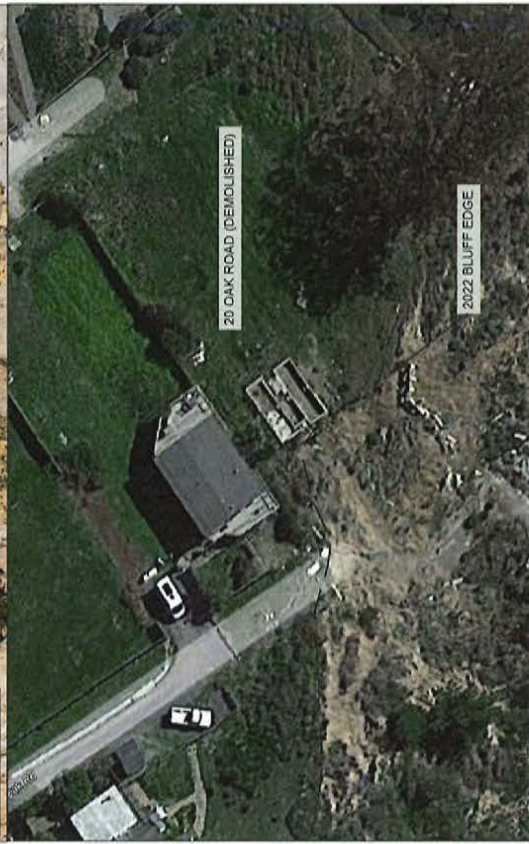
| | | <b>AERIAL IMAGERY 1972-2022</b> | |

REFERENCE: 1972 & 2005 Aerial Imagery: Copyright 2002-2018, Kenneth and Gabrielle Adelman, California Coastal Records Project, <https://www.californiacoastline.org/>  
 2009 & 2022 Aerial Imagery: Google Earth

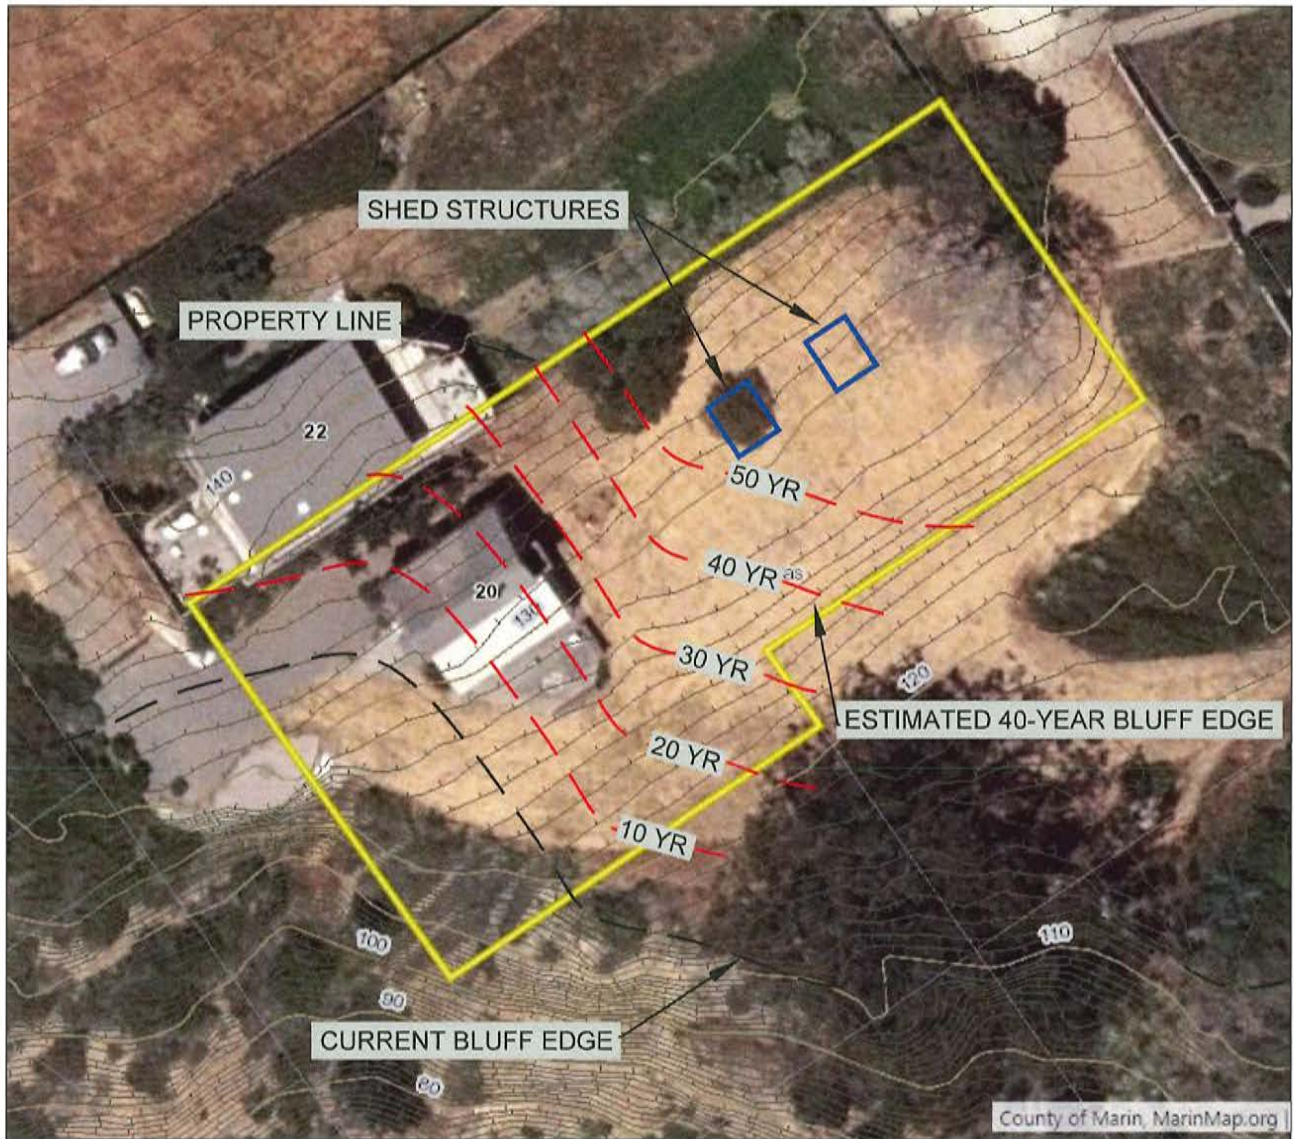
- 10 YR - ESTIMATED BLUFF EDGE, YEARS FROM CURRENT

REFERENCE: MarinMap 2019 LIDAR Topography, 2018 Ortho Imagery

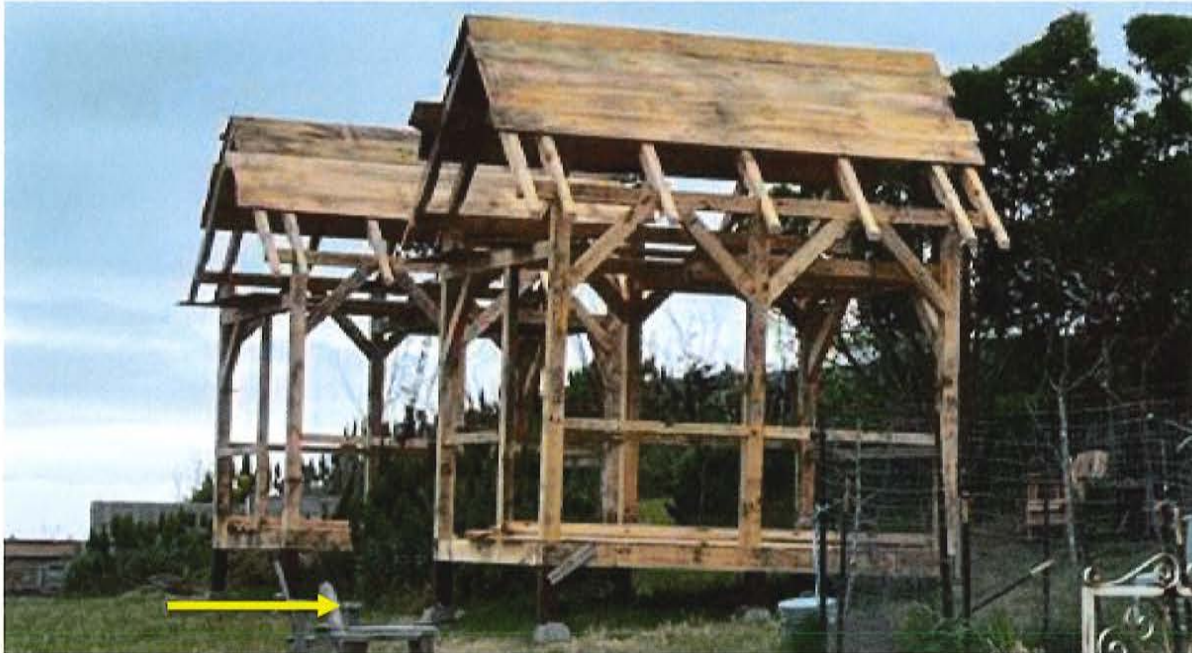
This photo was taken June 6, 2023, when the stop-work order was issued. Note the grade of the land indicated by the yellow arrow.

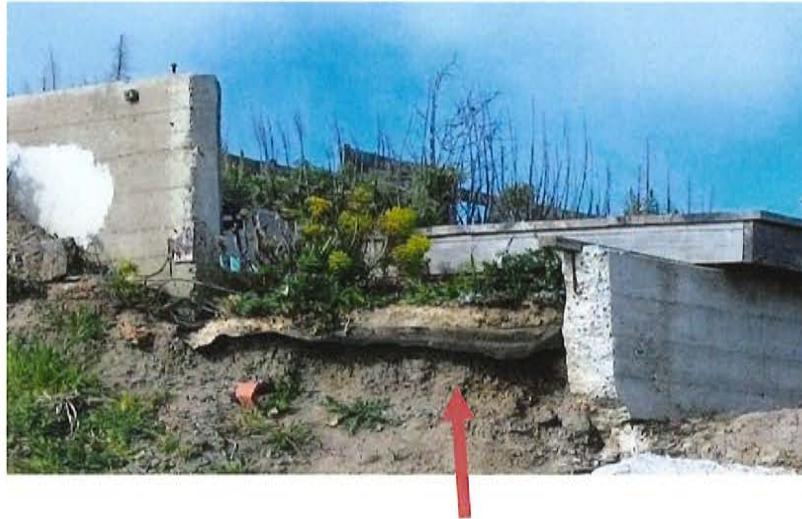
The geotechnical report’s use of different photos of the Property is also confusing and prevents an accurate understanding of the current bluff top location and therefore the structures in relation to the setbacks. For example, Figure 7 “Site Specific Bluff Retreat” uses an image from 2019. That image is possibly five years old and appears to have been taken prior to the 2019 collapse of the end of Oak Road. It’s a misrepresentation of the Property. Additionally, the image in Figure 6 labelled “Aerial Imagery 1976 - 2022” purports to show the 2022 bluff top edge. That photo is a Google earth image from January 25, 2021. The home at 22 Oak Road, visible in the photo is no longer there, having been relocated farther north due to the instability of the bluff. The current situation at the Property is shown below by the red arrow. The bluff top appears to be a minimum of 4 feet inboard of the remaining foundation. The use of inaccurate photos simply seems to be an attempt to manipulate the calculation of the setback from the bluff top. Based on the importance of the location of the bluff top areas, and the consistent inaccuracies in the planset site maps provided by the Owners, it is reasonable to request that a survey of the Property be obtained and provided.

The site plan and the geotechnical report for the Property are also inconsistent. The geotechnical report admits that the bluff top edge runs through the Property about 40 feet on the southwest side. The “current bluff top edge” presented on the site plan does not correspond with this depth. It is also disappointing that this inaccurate site plan is then reproduced in the geotechnical report.

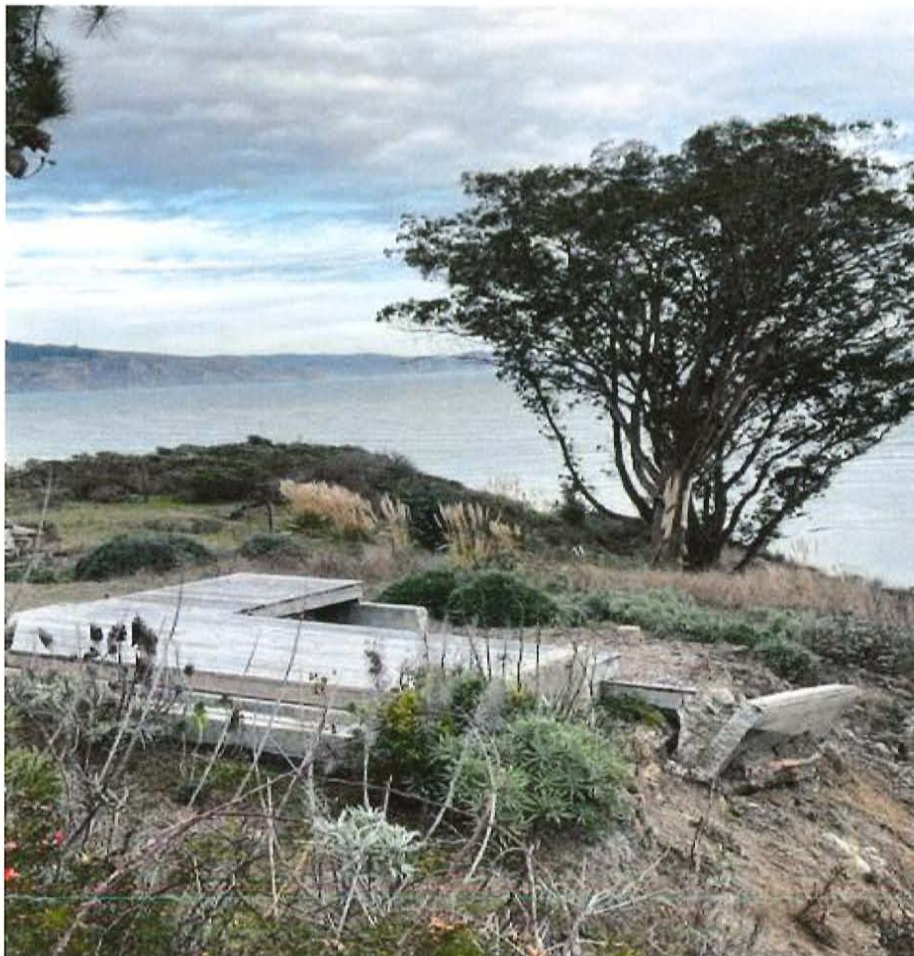
Photo from November 2024

The conditions that warranted leaving the foundation in place no longer exist. The home that was potentially threatened by the removal of the foundation has been moved significantly away from the bluff to a safer location. Furthermore, the foundation does not appear to be stabilizing the cliff face because it continues to erode dramatically, particularly following the Atmospheric Rivers of January and March 2023. In fact, in January 2023, a portion of the foundation separated and has begun to slide down the hillside towards Duxbury Reef. This hazardous condition poses a threat for users of Duxbury Reef. This separation of the foundation wall demonstrates that the erosion and sliding of the coastal bluff is active and ongoing.

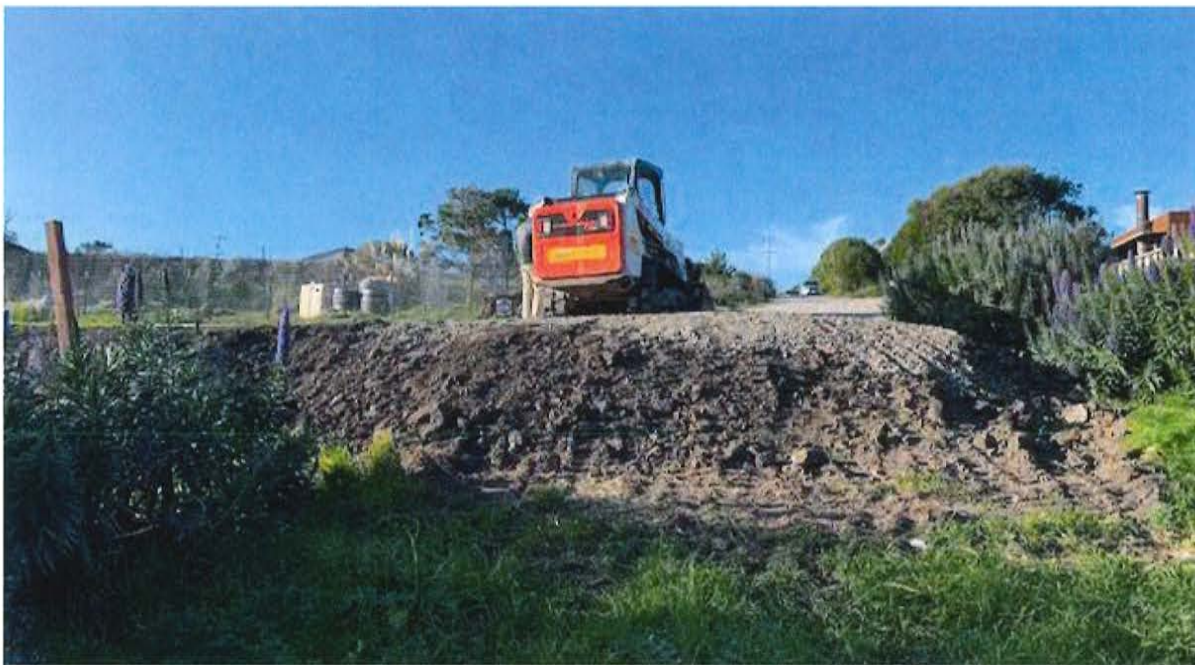
View of Nymph Road to north showing the steep incline created by unpermitted grading.

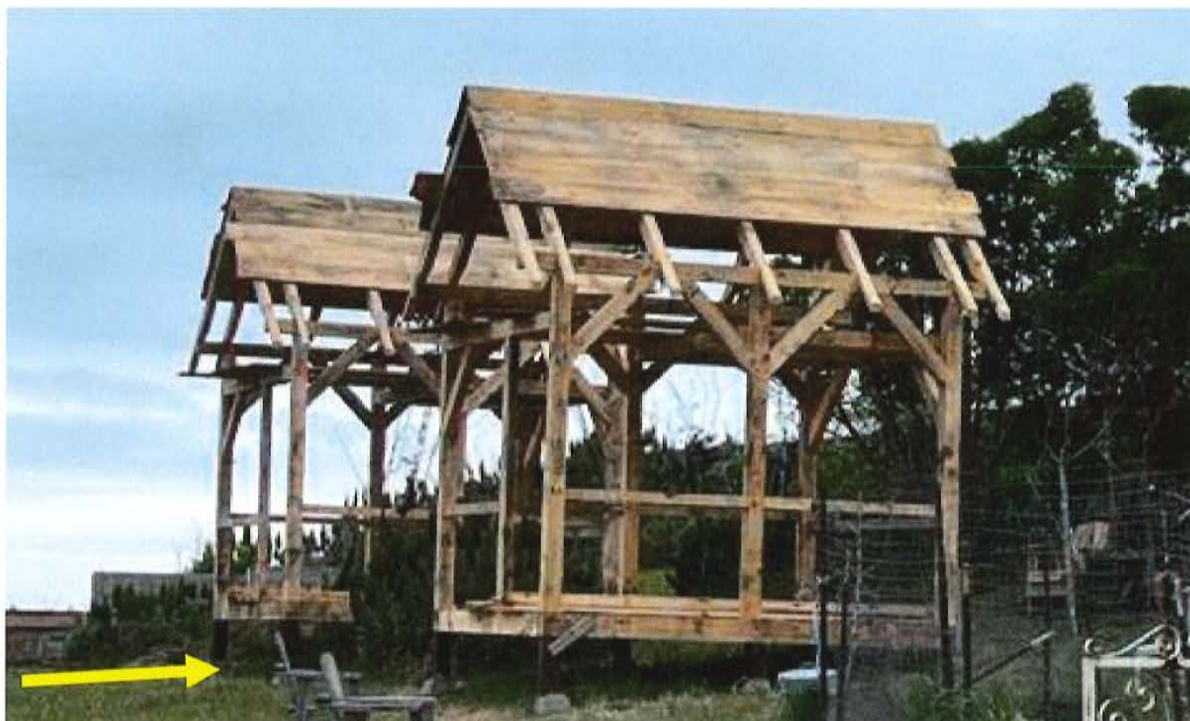
This photo was taken June 6, 2023, when the stop-work order was issued. Note the grade of the land indicated by the yellow arrow.

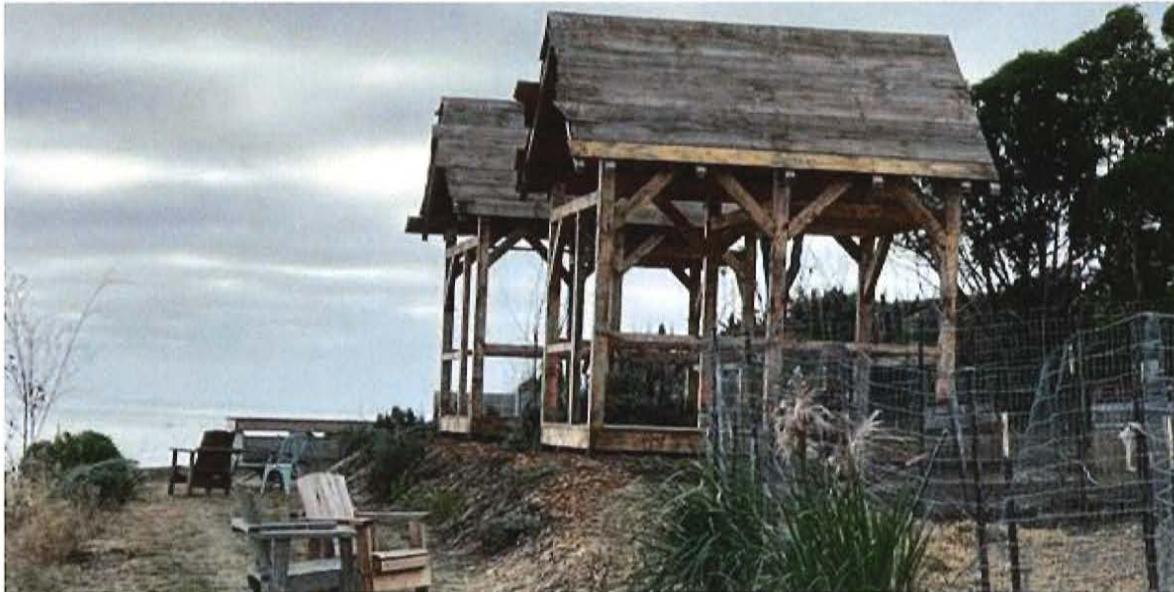
This photo was taken on September 6, 2023. Note the significant change in grade in addition to the completed roof and flooring.

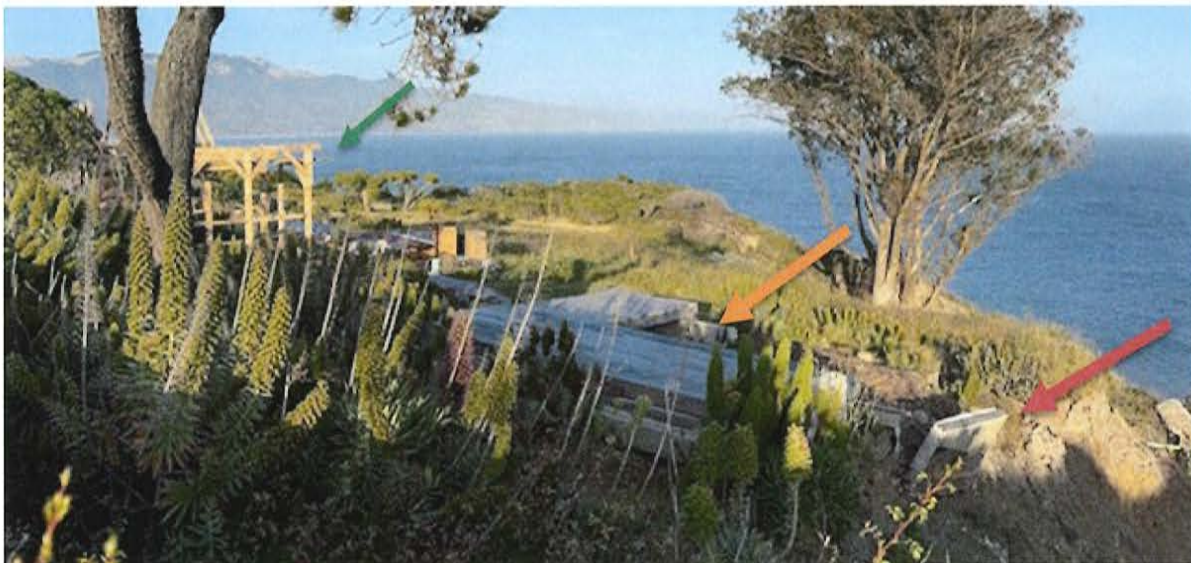
As shown in the photo below, the Property is a precarious site that has already suffered a significant landslide and remains threatened by cliff retreat. The bluff top area is approximately 30 - 35 feet inboard of the southwestern property line due to the previous landslides. The green arrow indicates one of the unpermitted structures and the red arrow indicates a part of the crumbling foundation of the previously condemned house on the Property that has begun to slide down the hillside towards Duxbury Reef. The orange arrow indicates the unpermitted wooden deck constructed by Yerington in or around 2021 on top of the remaining foundation of the condemned home. The wooden deck clearly is not set back a safe distance from the bluff top area and should be ordered removed.

It is noteworthy that the foundation wall shown above only separated in January 2023, demonstrating that the erosion and sliding of the coastal bluff is active and ongoing.
