SUBJECT: MCNEARS BEACH PIER – CURRENT DAMAGED CONDITION

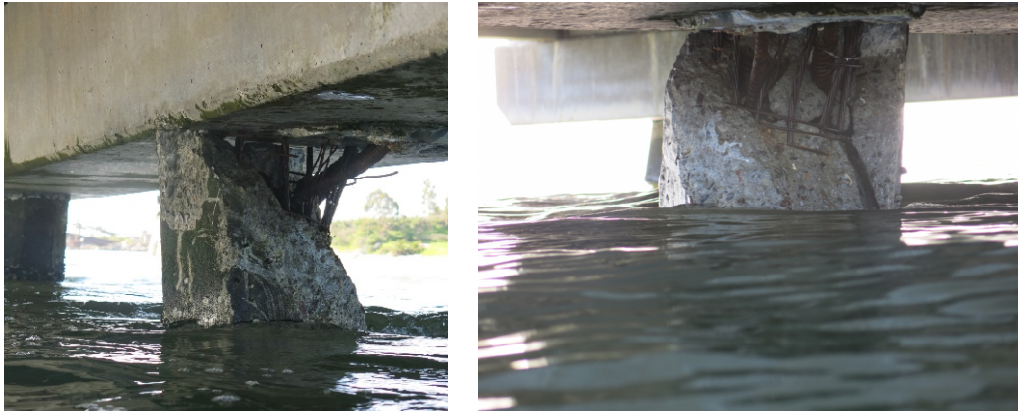
Figure 2: Damage at Pile F14, Bent 14 Northern Pile

Figures 1 and 2 present the location of the impact and two views of the damaged pile connection at Pile F14. See Figure 1 for pile bent numbers. The vertical and lateral support at this pile is significantly compromised. Currently, the pier deck dropped about 4 inches and is supported on a small area of remaining damaged pile concrete. Additionally, the damaged pile was pushed outward closer to the edge of the pile cap beam, as shown in Figure 3.

The observed damage at Pile F14 compromises the lateral capacity of this pile bent and increases the possibility of losing vertical support of the northeast end of the pier causeway. The concrete at the top of the pile is cracked and being held together by the light pile spiral reinforcing.

A small lateral movement could cause the pile to slide off from the pile cap beam causing it to collapse. Even in a small earthquake, the pile bent structure will move several inches. For reference, Liftech's calculations for the 2008 McNears Pier Damage repair project estimated the lateral deflection at Pile Bent 14 for the design earthquake is approximately 10 inches.

Any lateral loads/movement from a small earthquake or additional deterioration at the top of damaged pile (i.e. reinforcing fracture or concrete crushing) could cause the pile to slip off the edge of the pile cap. If vertical support at Pile F14 is lost, this section of the pier could collapse.

The current condition of the support at Bent 14 poses an imminent risk to property, human life, and the environment.

We recommend immediately mitigating this risk by shoring and repairing the pile as soon as practical.
