**McNEARS BEACH FISHING PIER
REPAIR APPROACH SUMMARY FOR PERMIT APPLICATION
FOR COUNTY OF MARIN**

**Prepared by Liftech Consultants Inc.
April 6, 2023**

Project No. 2421

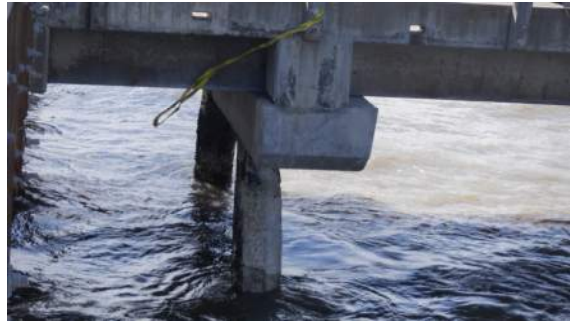
Photograph 4: Pile shifted from support

Liftech's site visit report, dated March 28, 2023, indicated the pile-beam connection at Pile F14 is severely damaged. The top of the pile has been translated from its original position. The pile cap rests on a small portion of the pile top. It appears that the north end of Pile Cap 14 has lowered approximately 3".

The temporary shoring concept uses a pair of steel beams to support a saddle under the pile cap near the damaged pile. These supports can later be used to raise the lowered section of causeway. This concept assumes that piles at Bent 13, Bent G, and Pile C14 are not compromised. Underwater pile inspection will need to be performed as soon as practical to confirm the assumed condition of these piles.

Permanent repairs will consist of leveling the northwest end of the causeway near the head, restoring the structural integrity of Pile F14, expansion joint, wooden railing system, and bull rail damage. Repair of Pile F14 will utilize a pile sleeve type repair and a doweled connection to the existing pile cap. The pile sleeve may extend down into the water. Repairs are intended to restore the structure to its pre-damage condition, not strengthen it. Liftech has not evaluated the existing design regarding its adequacy for current design codes.

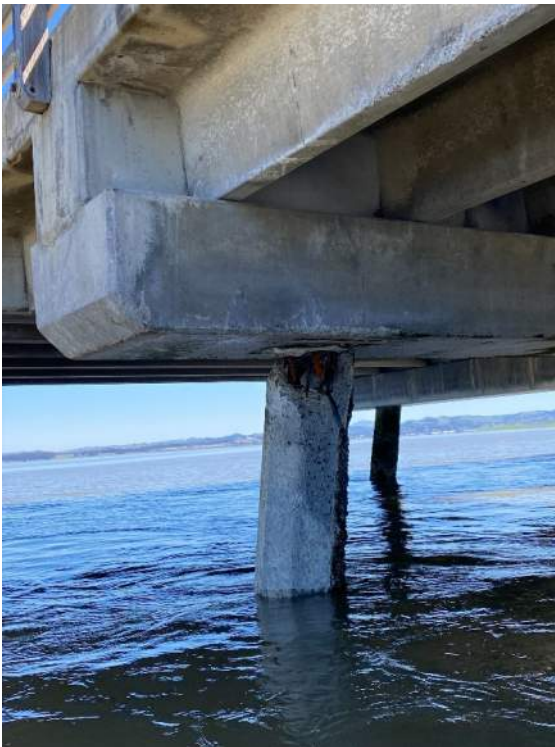
Photograph 5: Severe damage at the top of Pile F14

Translation restraint of the pile top is compromised. If subjected to lateral loads, it is possible that the pile cap could lose support. If pile support is lost, the end of the causeway could collapse. This condition should be mitigated immediately with temporary shoring to reduce the possibility of partial causeway deck collapse. Public access has been limited to the area landside of Pile Bent 12.

1. Mobilize crews, materials, and equipment.
2. Install jacking system and preload system.
3. Cut the existing rebar connecting Pile F14 to the pile cap.
4. Raise the north end of Pile Cap 14 to its original position.
5. As practical, reposition Pile F14 to original location.
6. Remove damaged pile concrete by chipping.

7. Repair Pile F14 using a pile sleeve type repair and a doweled connection to the existing pile cap.
8. Repair railing system, bull rail, and expansion joint.
9. Remove shoring system and repair cored holes in concrete deck.
10. Demobilize and cleanup project site.

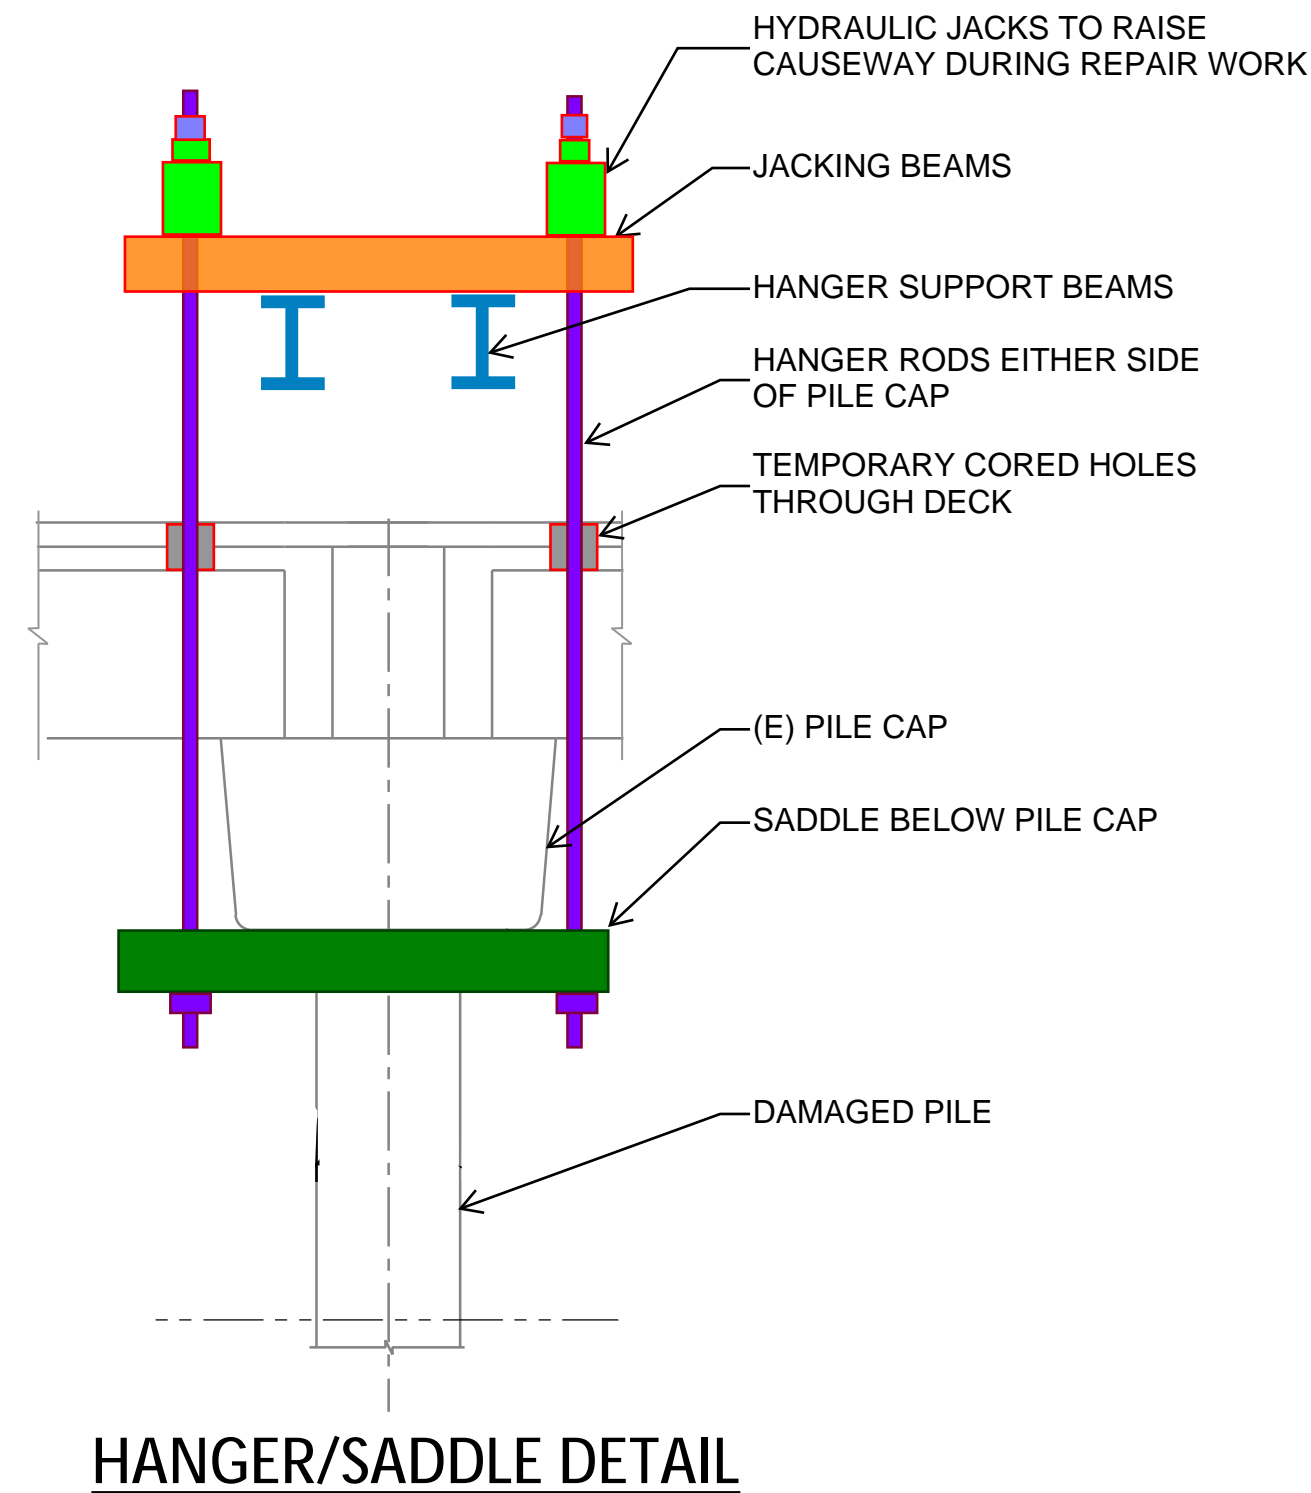
Phase 1: Temporary Shoring

This temporary shoring concept does not require driving temporary piles and most work can be performed above deck.

1. Mobilize crews, materials, and equipment.
2. Install a pair of Hanger Support Beams by a barge crane. Beams will be supported on timber or steel cribbing on top of deck.
3. Core drill 2 holes in deck to allow hanger rod installation.
4. Install Saddle Assembly to stabilize the north end of pile cap at Bent 14. Some work will be performed below deck and some parts of saddle may be below water at some tidal conditions.
5. Demobilize and cleanup project site.

None. All work is expected to be completed above water. Some parts of the steel saddle assembly may extend into water at some tide conditions.

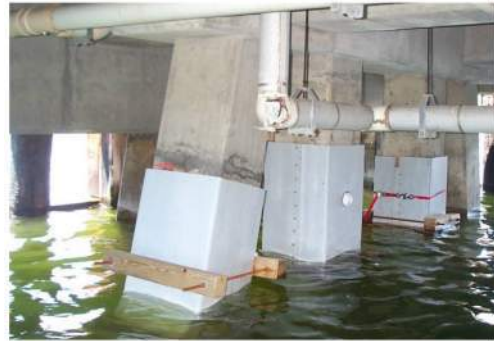
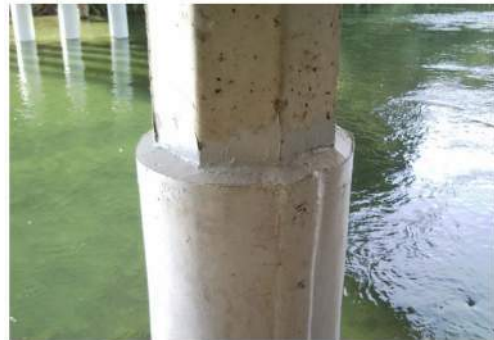
EXAMPLE PILE SLEEVE REPAIR CONCEPT

PLAN VIEW

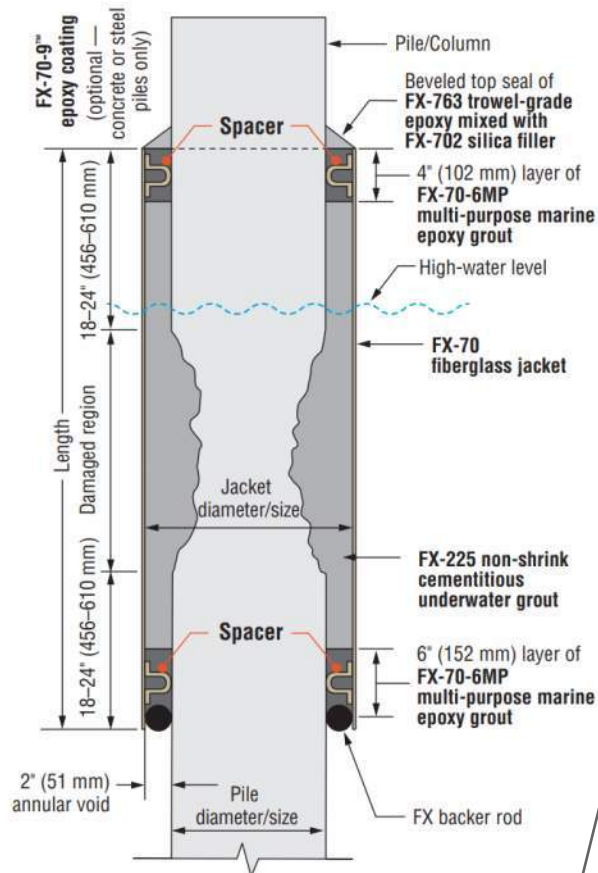
AT ONE DAMAGED (E) PILE, REPAIR DAMAGED PILE SEGMENT WITH A GROUTED PILE SLEEVE CONCEPT AND INSTALL DOWELS INTO (E) PILE CAP ABOVE TO RESTORE PILE-CAP CONNECTION.

EXTENT OF PILE DAMAGE IS NOT KNOWN AT THIS TIME, BUT PILE SLEEVE IS EXPECTED TO EXTEND BELOW WATER LINE.

FOR PILE SLEEVE REPAIR, WE PLAN TO LEAVE FIBER REINFORCED POLYMER (FRP) CONCRETE FORM IN PLACE AFTER POURING GROUT.
