#### **A PRESENTATION**

# McNears Pier Damage

## MARCH 21, 2023: VESSEL IMPACT

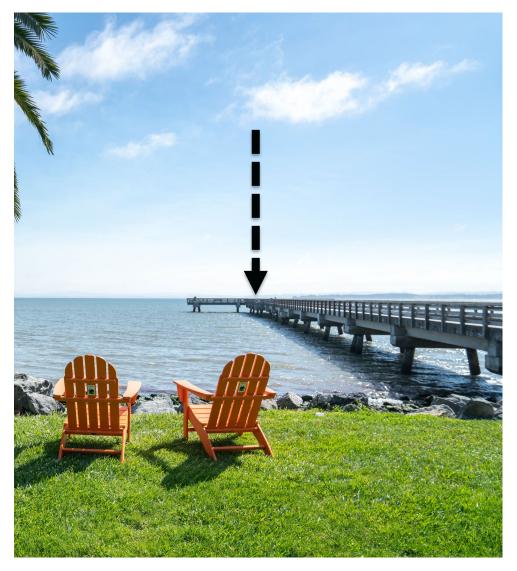
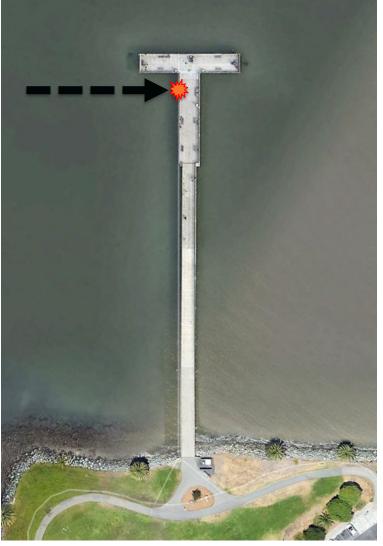
# **DAMAGE LOCATION**

- 40' concrete vessel
- Mooring broke loose during storm
- Vessel struck pier on north side.

- Railing section damaged
- Concrete curb cracked
- Water line broken

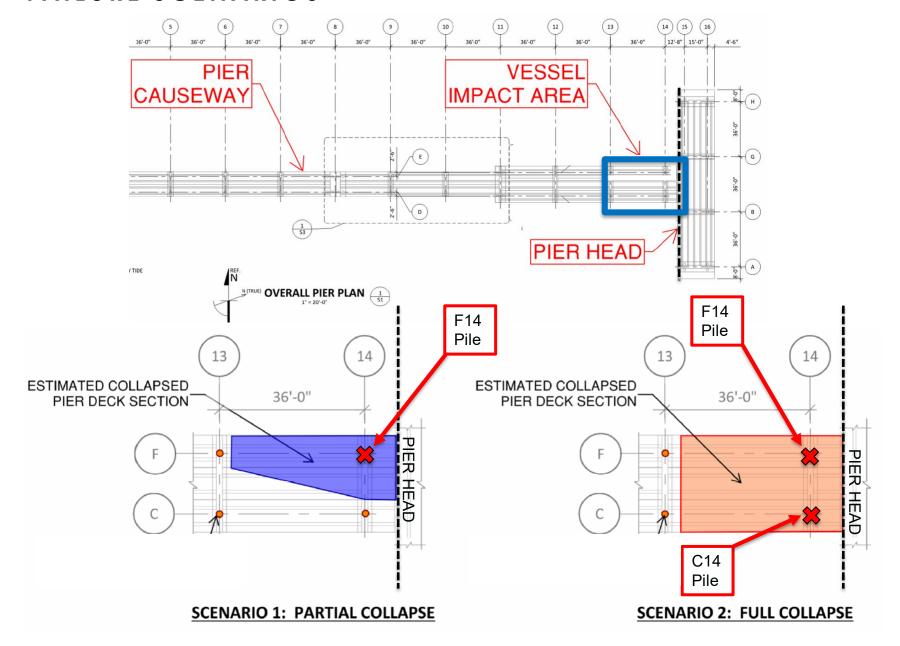
#### FAILURE SCENARIOS

- Damage puts pier at risk of collapse if piling fails
- Potential causes:
  - Vertical and lateral movement
  - Minor seismic activity
  - Deterioration from localized waves/currents
  - Another collision (even if indirect)
  - Storm wind and waves
- Failure risk increases with each day

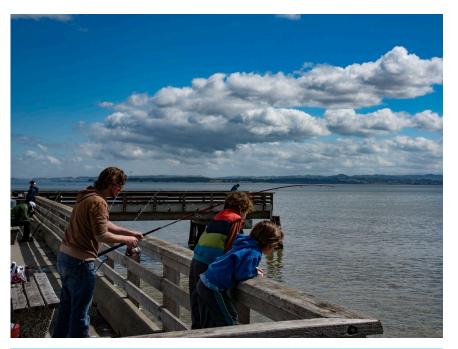
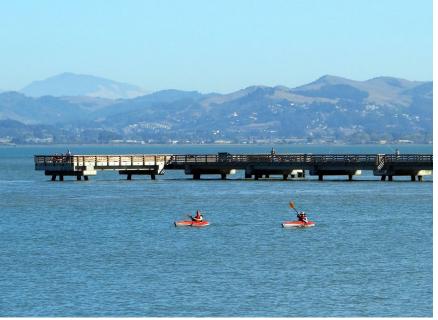
- Potential risk to human life if pier were to fail.
- Difficult to secure area and keep public away from pier.
