**SITE VISIT REPORT
MCNEARS BEACH FISHING PIER
UNDERDECK AND UNDERWATER DAMAGE REVIEW
FOR COUNTY OF MARIN
VISIT DATE: APRIL 14, 2023**

Prepared by Liftech Consultants Inc.
Preparation Date: April 20, 2023

Project No. 2421

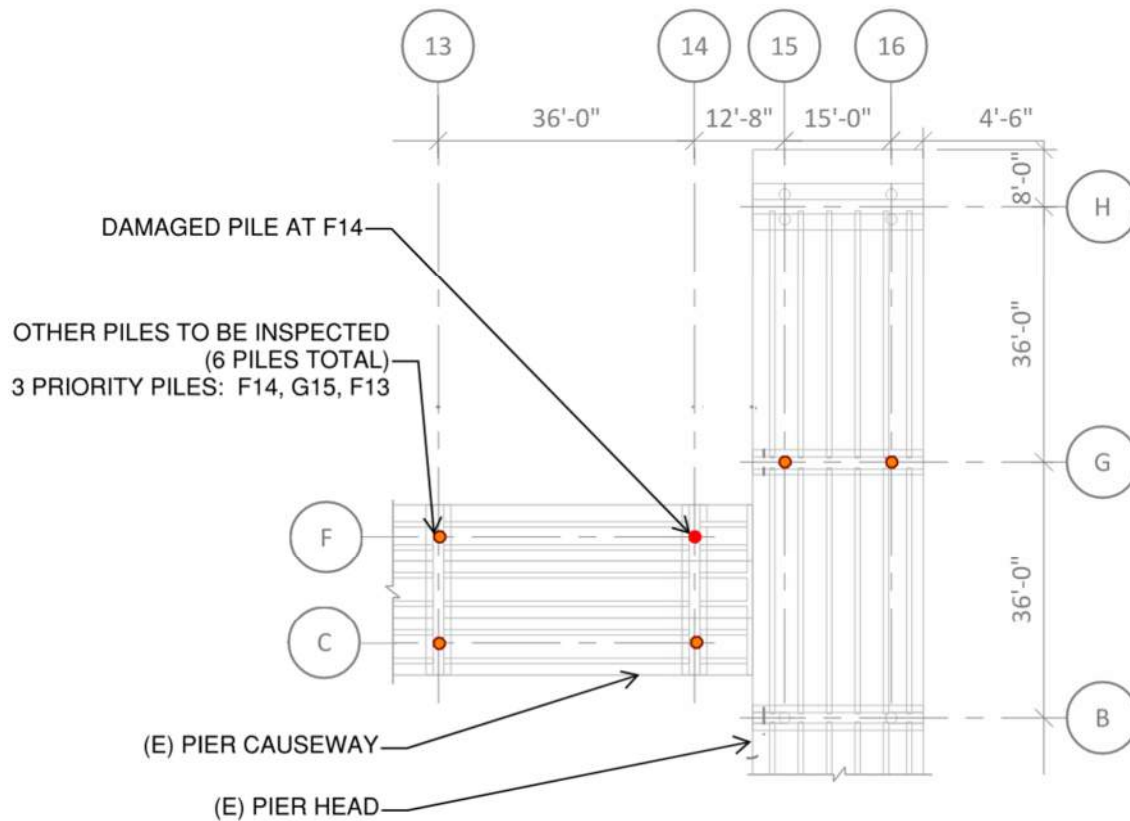
Figure 2: Inspected piles

URI performed an underwater inspection of the piles identified in Figure 2. The inspection consists of a close visual and tactile examination of the pile condition. Marine growth was not removed as part of the inspection. The focus of the underwater inspection was identification and measurement of damaged areas of the existing concrete piles.
