Appendix A Woodacre Creek and San Geronimo Creek Microbial Source Tracking

Woodacre Creek and San Geronimo Creek Microbial Source Tracking - Winter 2016 to Summer 2017

WOODACRE WASTEWATER

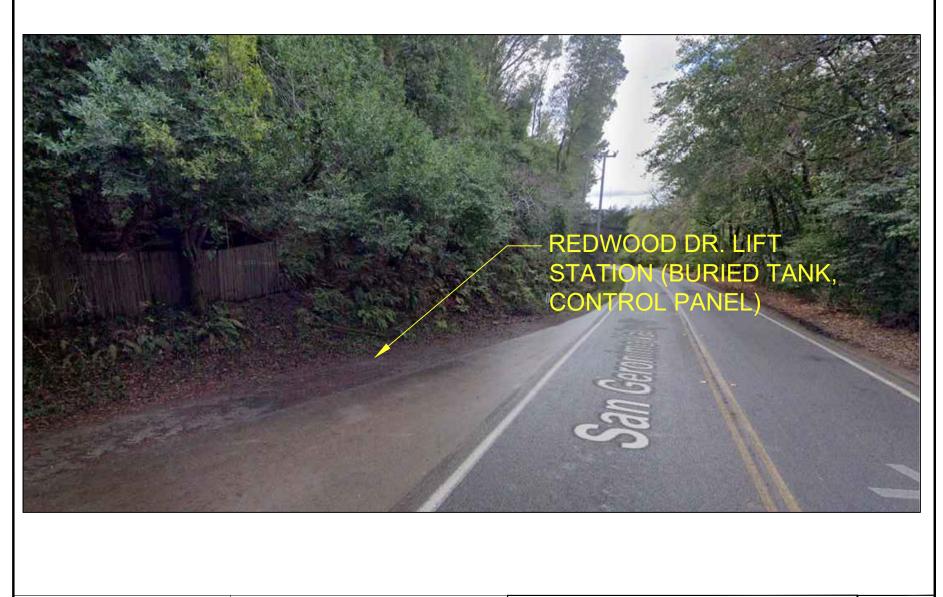
Date:	8/12/24	Civil REDWOOD DR. LIFT	FIGURE
Drawn:	ER	& Water Resources STATION LOCATION	
Appr'd:	NH	(510) 238-6114 WOODACRE WASTEWATER	D-5
Project No	: 2200054	E N G I N E E R I N G C O R PRusta(610) 230-4220 P.O. Box 70356 1220 Brickyard Cove Road Point Richmond, CA 94807

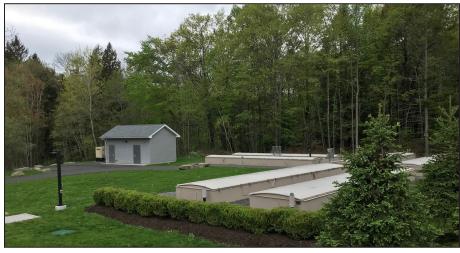
An AdvanTex[®] AX-MaxTM Wastewater Treatment System – with its low life-cycle costs and small footprint – was chosen as the best replacement for a failing treatment plant in the community of Pinebrook. (Photo courtesy of Julie Barown.)

Solution The Dutchess County Water and Wastewater Authority commissioned a Preliminary Engineering Report to recommend alternatives for replacing the failing RBC. Three options were evaluated: a brandnew RBC, a membrane bioreactor, and a packed-bed filtration system. Because of its many advantages – including low life-cycle costs¹, consistently high-quality effluent, minimal operation & maintenance requirements, and a small footprint – an AdvanTex (packed-bed filter) Wastewater Treatment System was recommended.

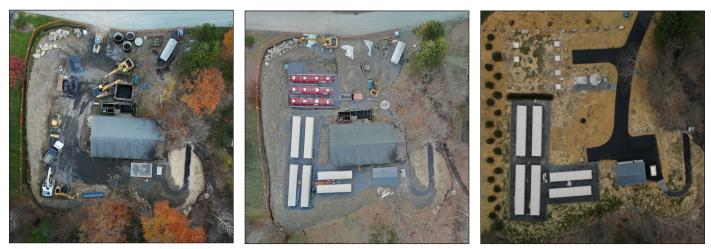
Between November and April, six AdvanTex AX-Max units were installed to replace Pinebrook's failed rotating biological contactor (RBC). The final photo on the right shows that the RBC and the building once housing it have been removed. (Photos courtesy of the Dutchess County Water and Wastewater Authority.)

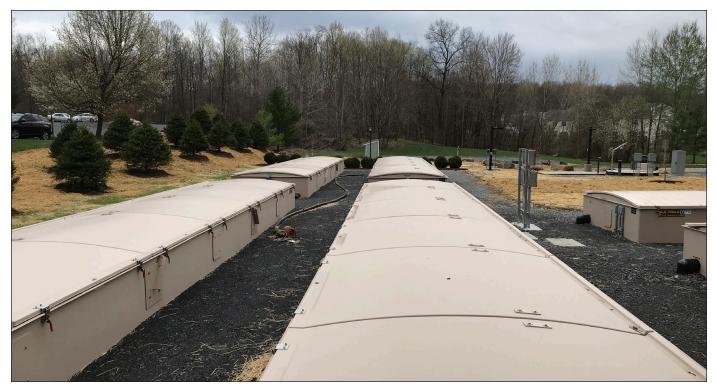
The AX-Max uses a passive, attached-growth treatment process that is inherently stable and has minimal operation and maintenance requirements. The Max also minimizes noise and odor, making it "neighborhood-friendly." (Photo courtesy of the Dutchess County Water and Wastewater Authority.)

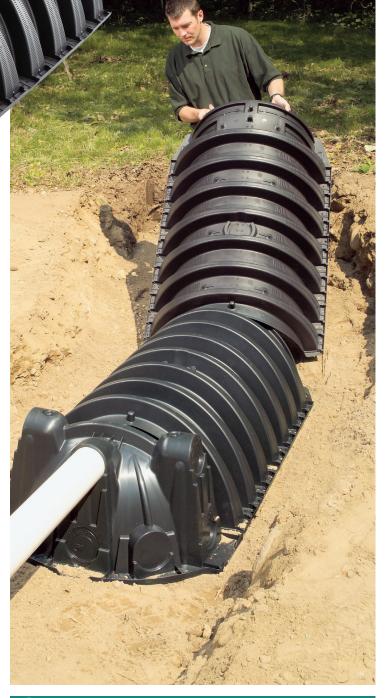
- · Tear-out seals on inlet ports provide a tight fit to the pipe
- Eight molded-in inlets/outlets allow for maximum piping flexibility
- · Fits on either end of the Quick4 High Capacity Chamber
